# Technical Assistance for the Protection of Damaged Cultural Heritage in Nepal

*Project Report*

May 2017

Tokyo National Research Institute for Cultural Properties

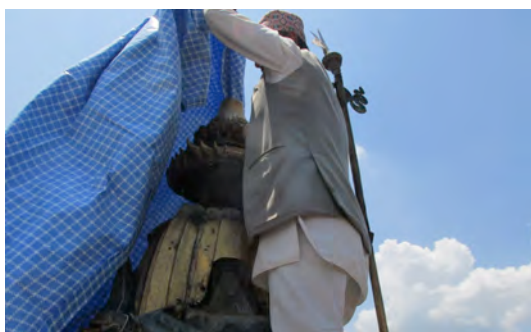
Fig.2-2-3 Waterproofing work of the pinnacle of the Aganchen Temple

In addition to the above measures, the deformed pinnacle of Aganchen Temple was covered with water proof sheets to prevent the water leakage in the rainy season.

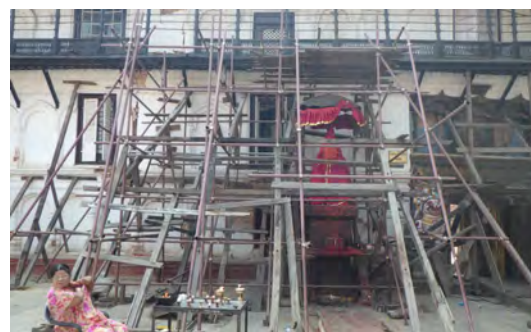
from the outside, but the pillars located below the Aganchen Temple were inclined significantly, and the outer western walls were heavily damaged. An emergency stabilisation measures followed by an extensive restoration are needed for they may collapse.

Fig.2-2-4 Before the stabilisation work (May 2016)

1. Wooden frames were installed and fixed inside each room on the lower storeys of Aganchen Temple in order to prevent further distortion of the structure.
2. Steel pipes were installed to support the outer wall at the levels of floor joists, from the west side of the west wing of Mohan Chok, in order to prevent the collapse of the outer wall.
3. A metal protective mesh was placed in order to prevent the bricks or the tiles from the damaged walls or the roofs from falling on pedestrians passing through Hanuman gate and worshippers to the Hanuman statue.

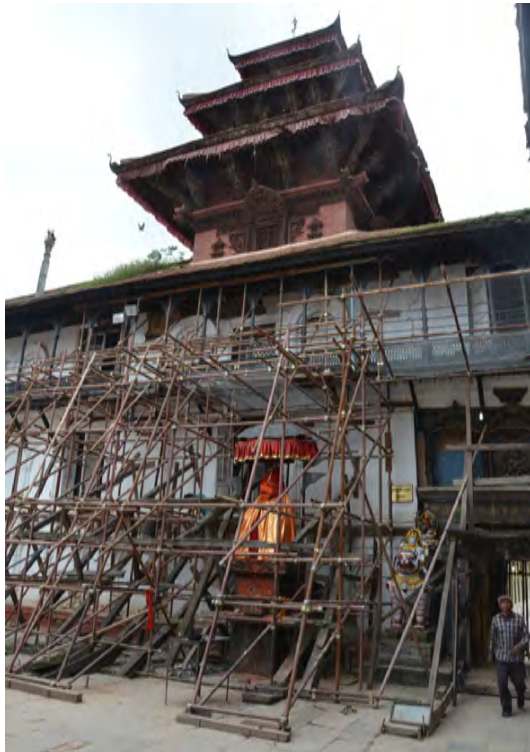
Aganchen Temple is located on the top of the southwest corner of the building group which surrounds Mohan Chok whose south side Hanuman gate is connected to (Fig.3-1-10). The extent of damage and deformation observed in these buildings are as follows.

From the outside, there is no significant damage. Simple observation reveals inclination of the pinnacle on the top, displacement of roof tiles, and partial slackening of the brick joints around the corner wall. No significant inclination of the whole tower can be observed (Fig.3-1-11). We have not yet conducted an investigation of this tower entering inside due to religious reasons but this investigation is indispensable to evaluate its structural soundness accurately.

Fig.3-1-10 General view of Aganchen Temple

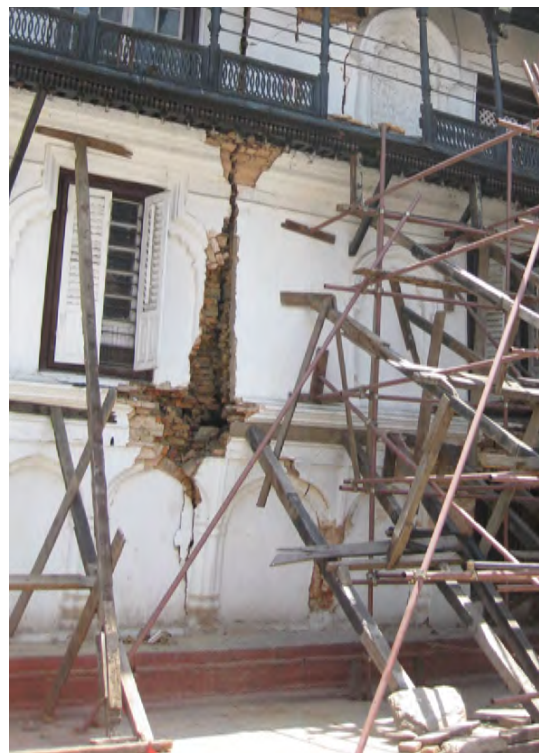
Fig.3-1-13 Gap on the outer western wall of the building below Aganchen Temple

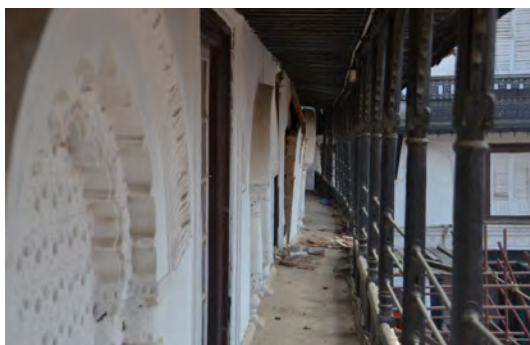
Fig.3-1-14 Damaged condition of the west balcony on the third storey of the west wing of Mohan Chok

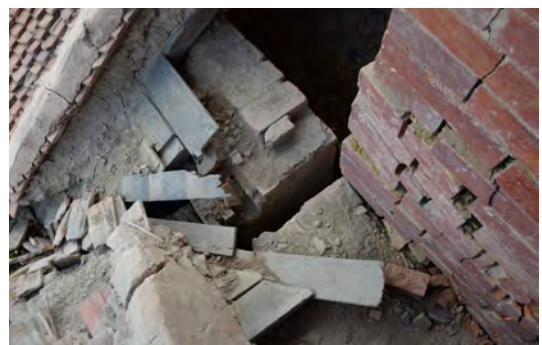
Fig.3-1-15 Gap between the south wing of Mohan Chok (Left) and the Aganchen Temple (Right)

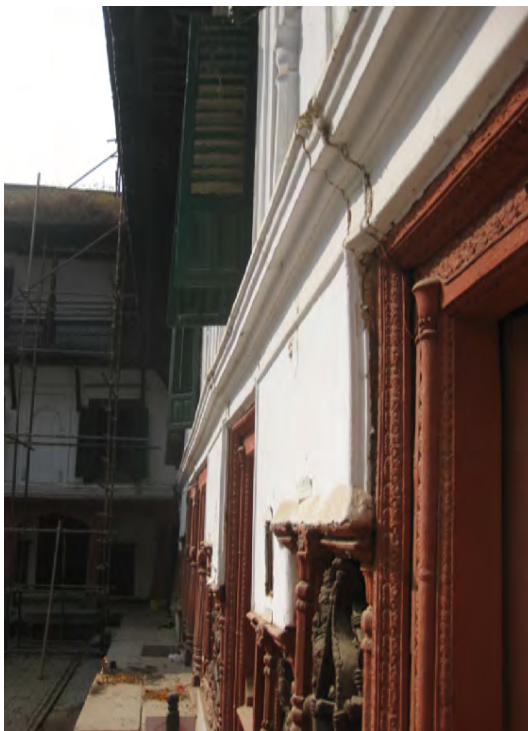
Fig.3-1-18 Deformation condition of the east side of the west wing of Mohan Chok

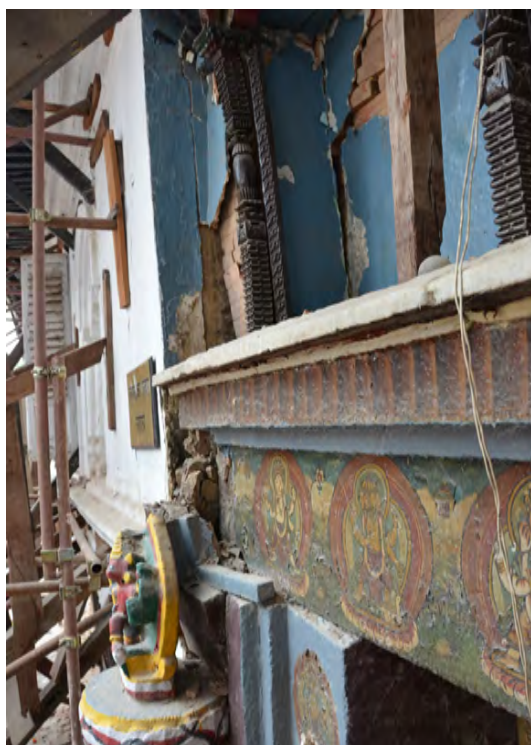
Fig.3-1-20 Damage condition of the upper part of Hanuman gate

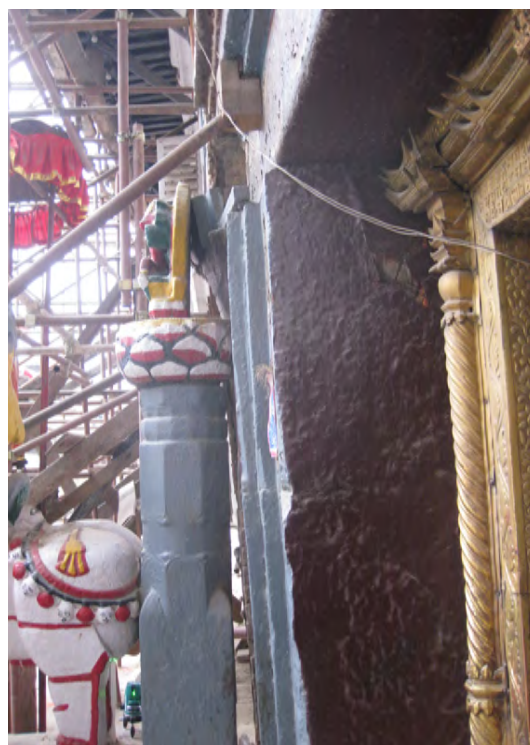
Fig.3-1-21 Inclined north gatepost of Hanuman gate

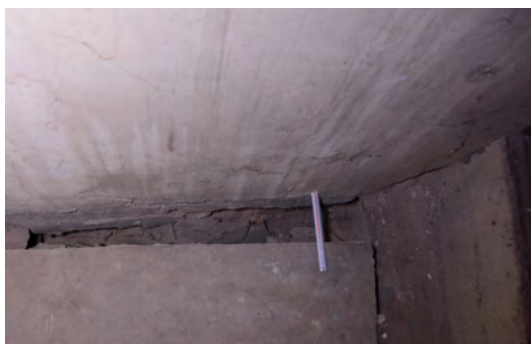
This building also twists and the angle of the inclination of the outer western wall is steeper on the north side under the influence of the inclination of the part right below Aganchen Temple. The northern pillar of Hanuman gate slants forward as well (Fig.3-1-20, 21). There is a gap between the west edge of the second floor (the floor of the third storey) and the wall (Fig.3-1-22). The RC

Fig.3-1-22 Gap between the second floor of Hanuman gate and the outer western wall

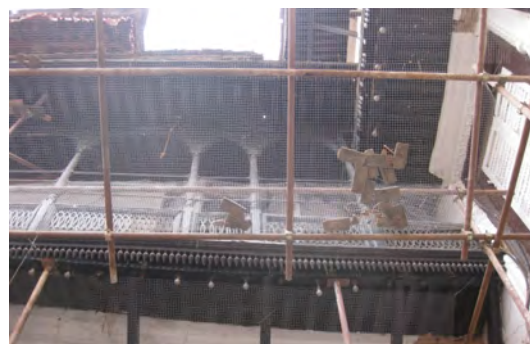
Fig.3-1-23 Tiles felled from the roof above Hanuman gate

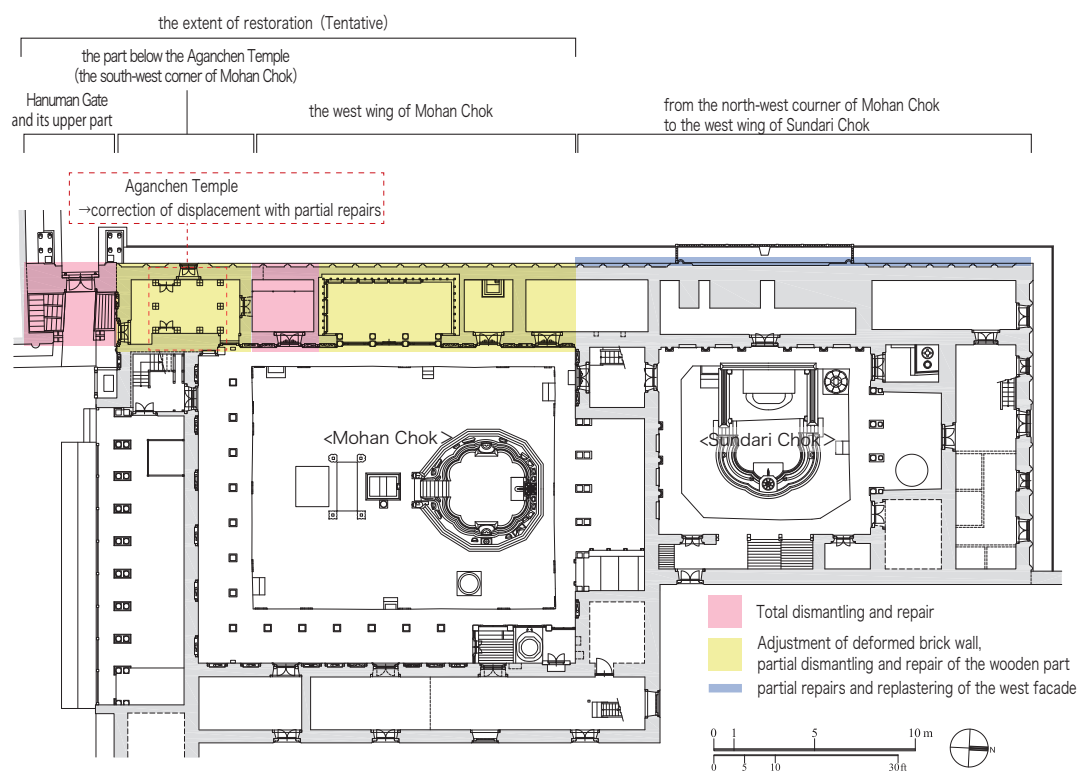
Fig.3-1-25 Provisional scope and policy for restoration

With regard to the west wing of Mohan Chok, the wooden parts such as the roof, floors, and balconies (except for the floor joists) will be dismantled and the southern end of brick wall will also
