出羽三山神社合祭殿内板戸彩色保存処置

受託研究報告 第 29 号

茂 木 曙

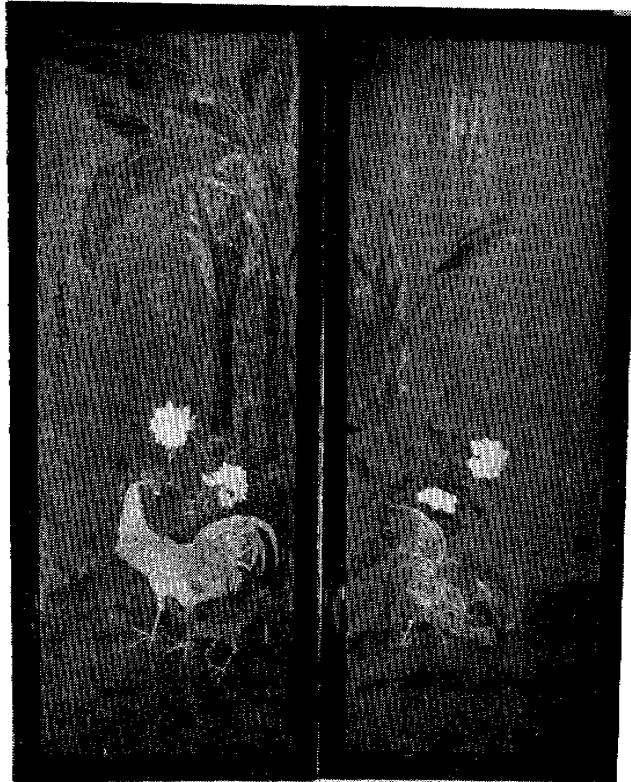
図-2 草木と鶏の図 (処置後)

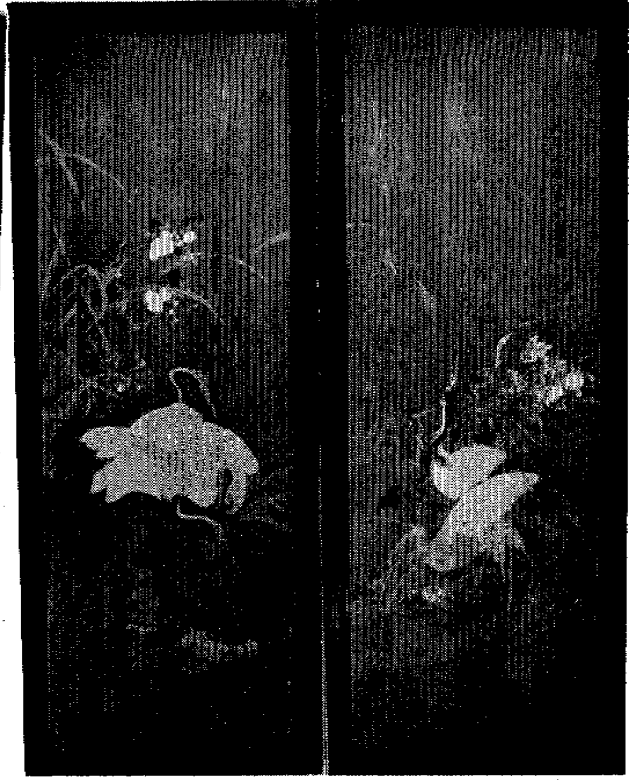
図-3 草木と鶴の図 (処置後)

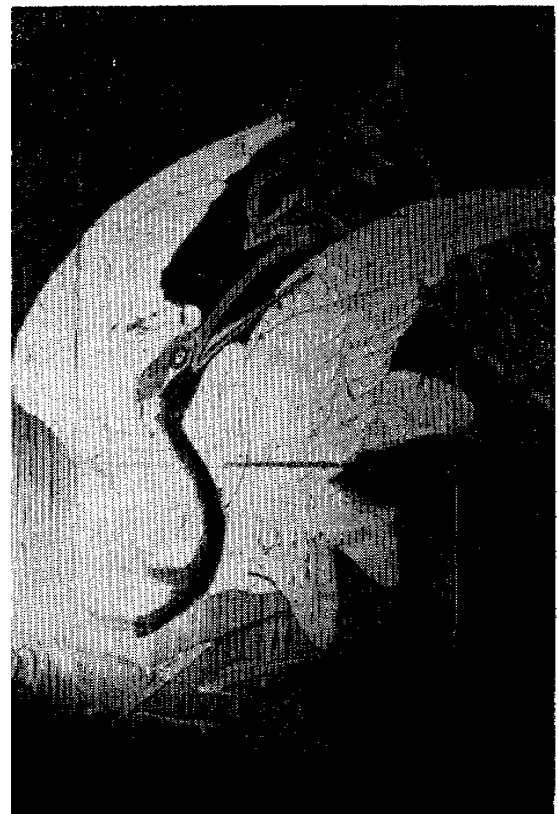
図-5 鶴の図の剥落状態の一例 (処置後)

ほとんどの板戸に見受けられる雨滴ようなしみのうち、泥土の付着物を、やや硬度の高い毛筆（油絵用）を用いて丹念にとり除き、更に顔料のない部分について刷毛で水洗いをして拭い去った。それによって付着物はほとんど完全に除去できたが、永い間にその部分の木の素地が、変色していて、痕跡が斑点となって残った。彩色の上の泥土は顔料に結合して顔料からとりわけるのが仲々にむづかしい。先ず筆先や木の筥の先端でかるくとり去ったあと、彩色の剥落どめの目的で、PVA 2% 溶液を十分に含浸させて、異物がある程度軟化したところで筆先で拭うようにして清掃した。胡粉層の浮上がりに対しては、PVA 4% 溶液を注射器または筆先によって木の素地との空隙に注入し濾紙を当てて押さえて固定し、処置を終わった。
