カンボジア・アンコール・タネイ寺院遺跡東門の修復 Restoration Work of the East Gate of Ta Nei Temple, Angkor, Cambodia

東門の修復 Restoration of the East Gate

カンボジア・アンコール・タネイ寺院遺跡東門の修復
担当:文化遺産国際協力センター保存計画研究室

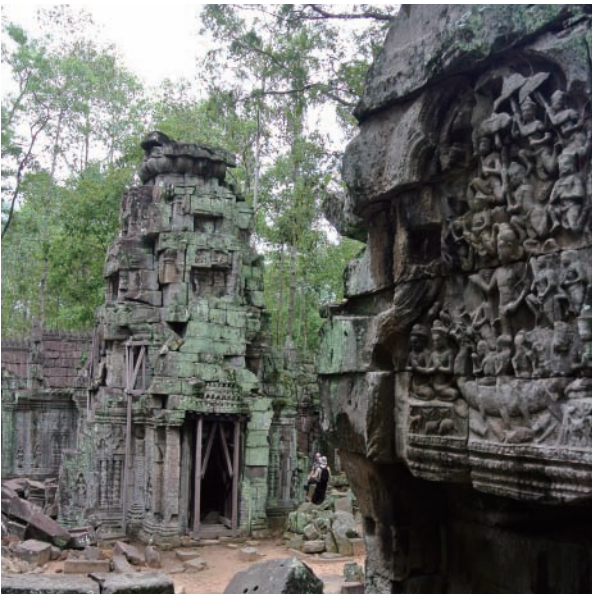
左上:内回廊内に建つ中央祠堂(手前)と東祠堂(奥)
右上:樹木に覆われた中心部の景観(内回廊北面)
左下:東門東面(正面)ペディメントの彫刻
右下:修復前の東門(北東から)
Upper left: Central Tower Shrine (front) and East Tower Shrine (back) in the Courtyard
Upper right: Densely forested landscape of the central area (north side of the Inner Gallery)
Lower left: Carving on the east (front) pediment of the East Gate
Lower right: East Gate before restoration (northeastern view)

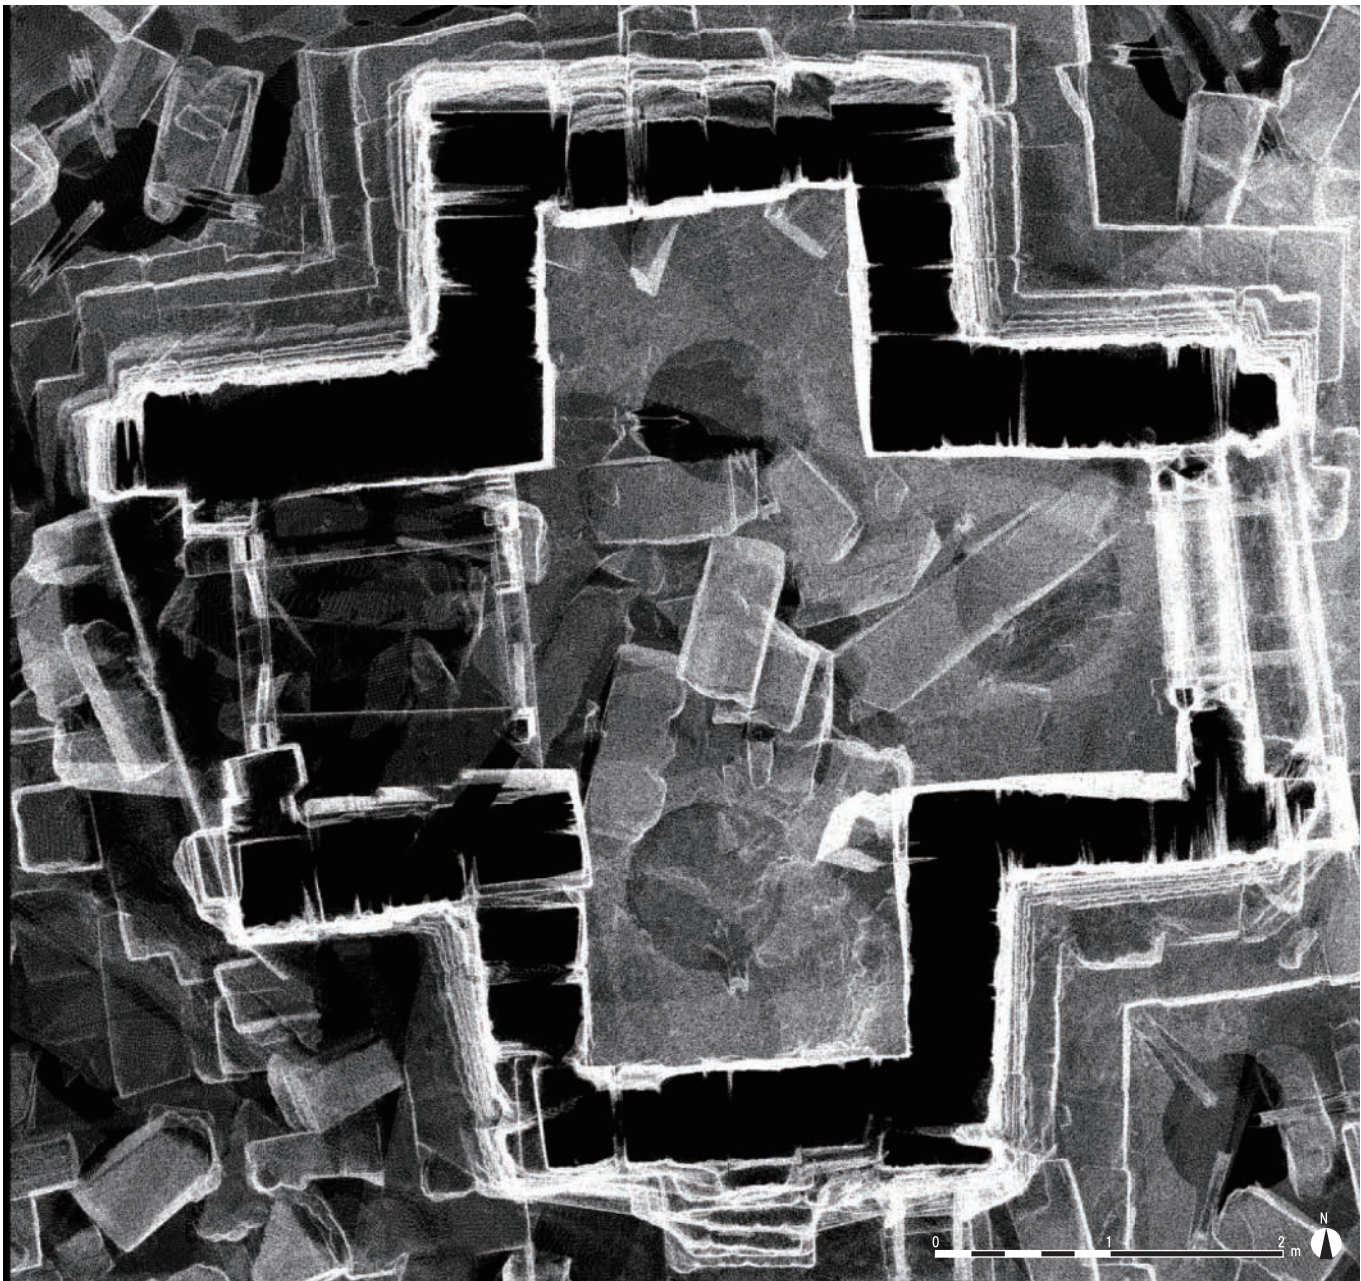
下：レーザー計測図を用いた破損調査

Below: Analysis of structural deformation by using laser scanning

屋内堆積物の除去と必要な記録作業の完了後、10月16日から壁の解体に着手し、11月4日に壁最下層の石材(第16層)を残して解体を完了しました。解体に伴う調査を通して、樹根などが石材の目地に入り込み、建物が変形する一因となっている様子が確認できました。

After the cleaning and documentation works, dismantlement of the wall was started on October 16 and was completed on November 4 leaving the lowest layer of the wall (Layer 16). It was confirmed during this process that tree roots penetrating into joints between stones had caused the building deformation.

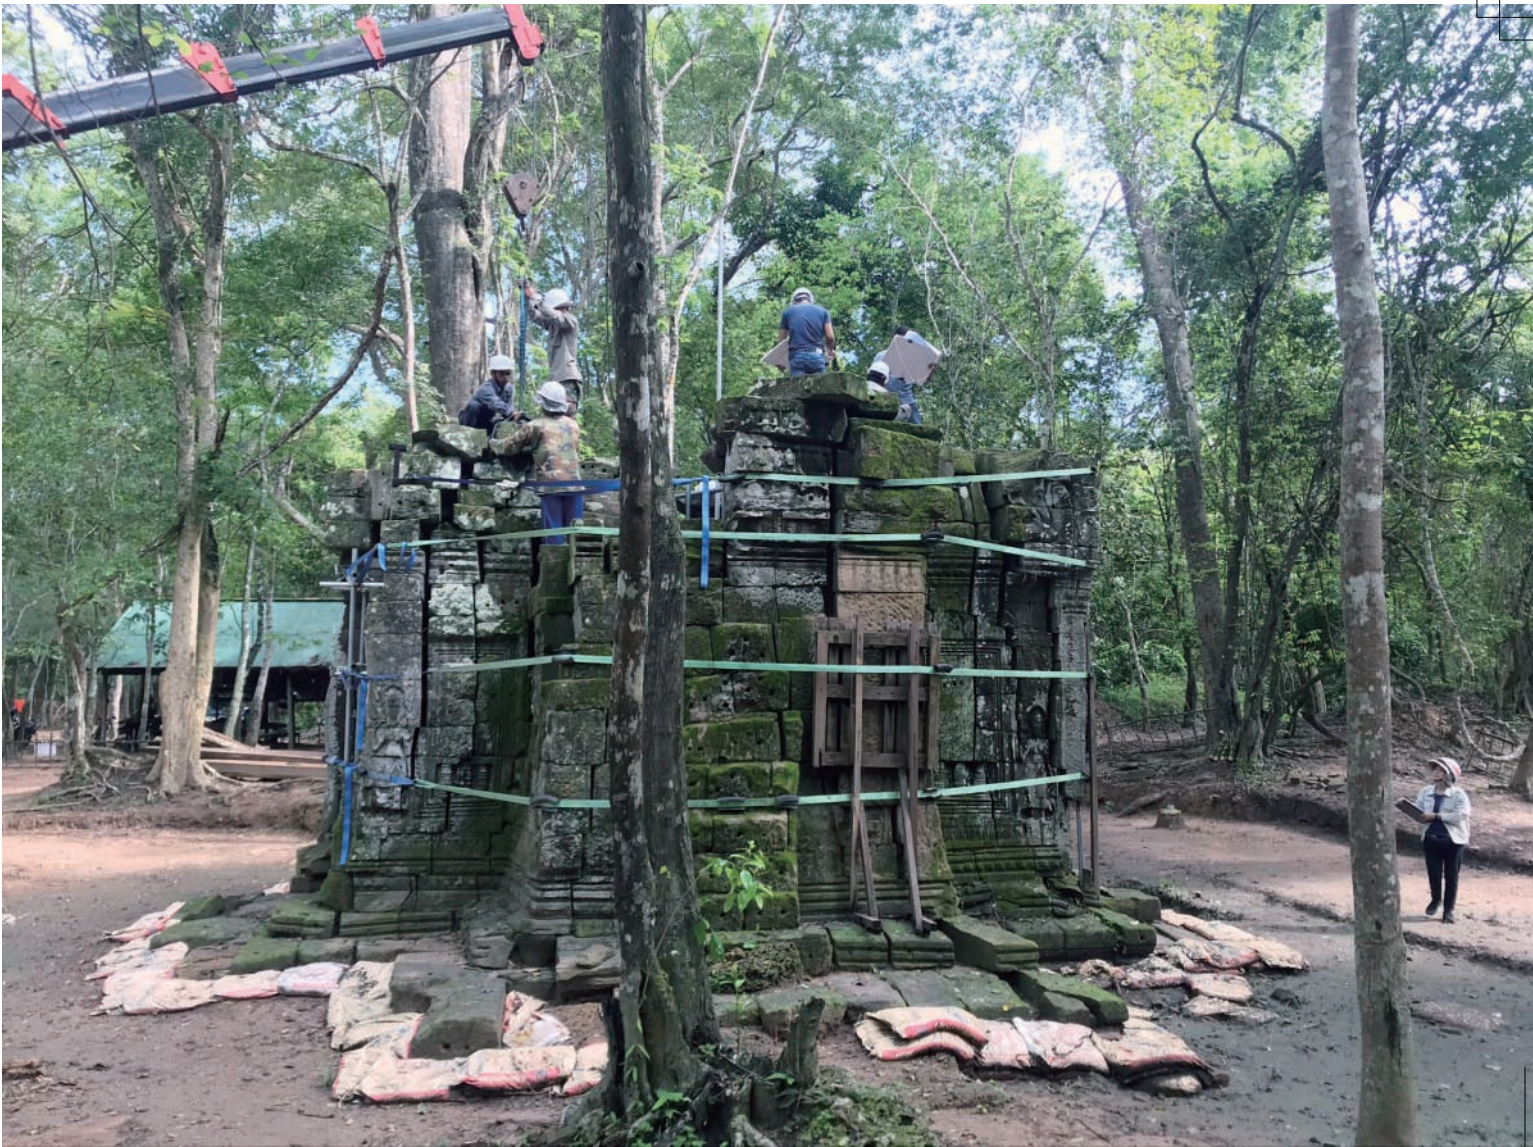
As the unevenness of the floor and the base structure was observed, the archaeological and geotechnical investigations were conducted during December 2–20 after completion of the wall dismantlement, aiming to understand the condition of the base structure.

上： 屋根の解体作業
中左：壁の解体作業
中右：基礎構造の発掘調査と地盤強度試験
下： ボールカメラを用いた写真測量

Above: Dismantlement of the roof structure
Middle left: Dismantlement of the wall structure
Middle right: Archaeological research and soil testing of foundation structure
Below: Photogrammetry with high pole camera
