国宝銅造阿弥陀如来坐像(鎌倉大仏)の保存修復

Conservation of the Great Buddha of Kamakura

近代の文化遺産の保存修復に関する研究

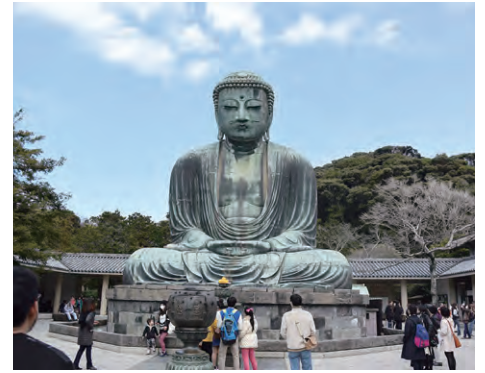
修理後の国宝銅造阿弥陀如来坐像
The Great Buddha of Kamakura, after conservation

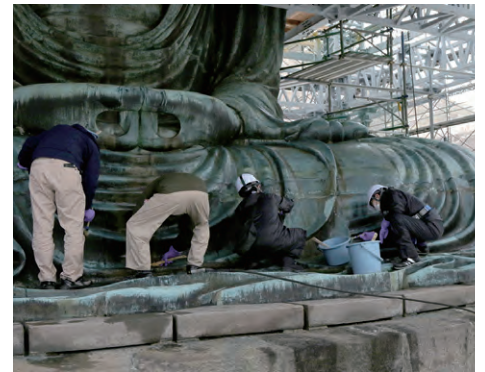
鎌倉大仏のクリーニング作業の様子
Cleanig of the Great Buddha of Kamakura

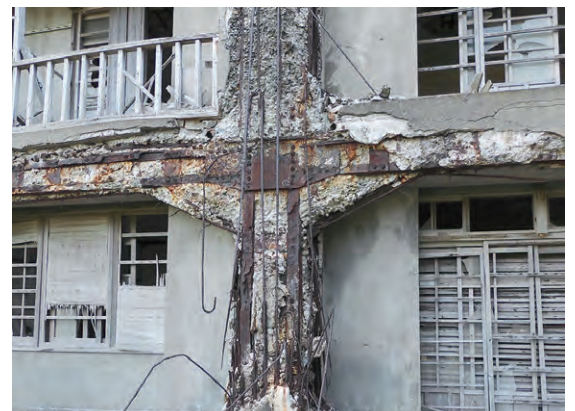
端島(軍艦島)の劣化した鉄筋コンクリート造集合住宅。鉄材の錆によりコンクリート壁が劣化剥離している。
Reinforced concrete apartment house on Hashima Island (Battleship Island, Nagasaki City, Nagasaki Prefecture)
The concrete wall was deteriorating due to the rusting of the steel structure.
