# Project for Investigation of Damage Situation of Cultural Heritage in Nepal

Project Report

National Research Institute for Cultural Properties, Tokyo

2016

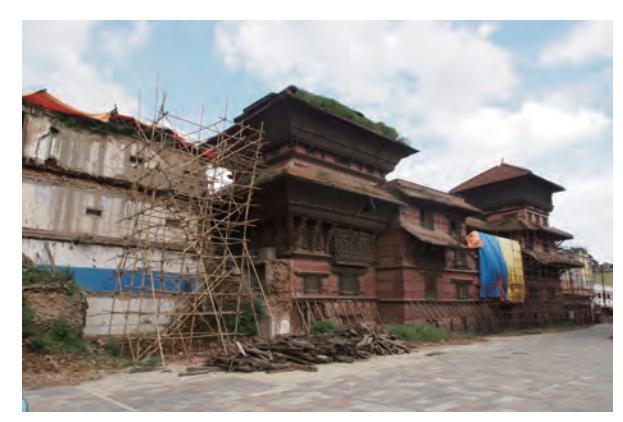
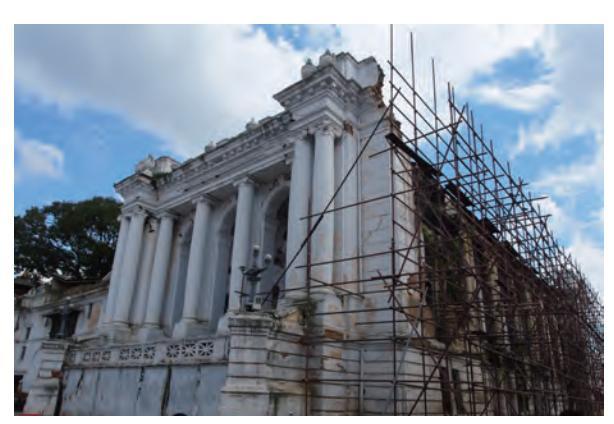
Fig.2-1 Basantapur Bhawan, whose 7th to 9th floors were Fig.2-2 Gaddi Bhaithak collapsed

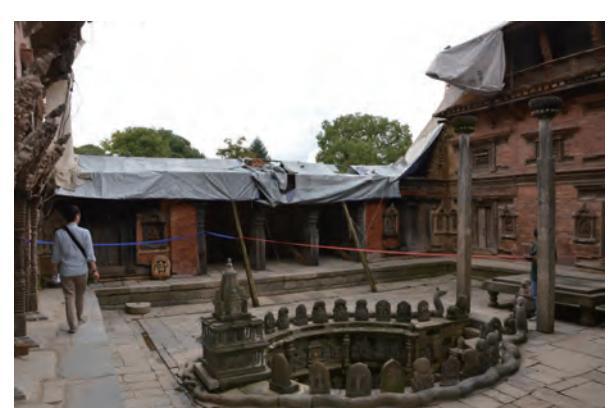
Fig.2-3 Collapesed east-wing of Sundari Chok

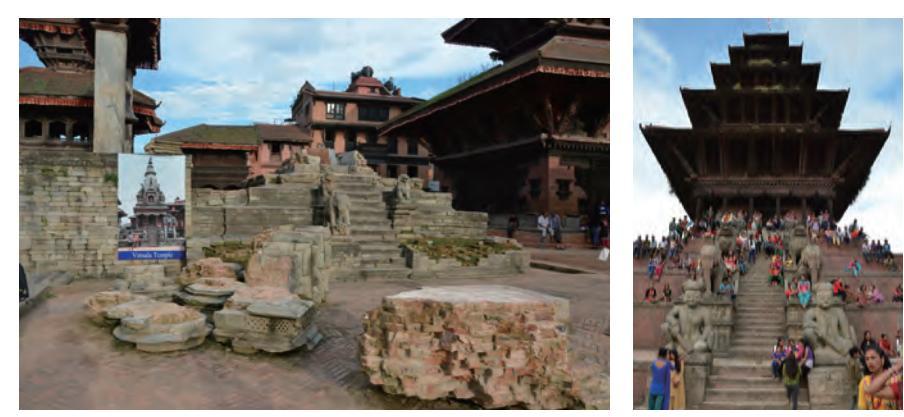
Fig.2-5 Basara Devi (Completely collapesed)

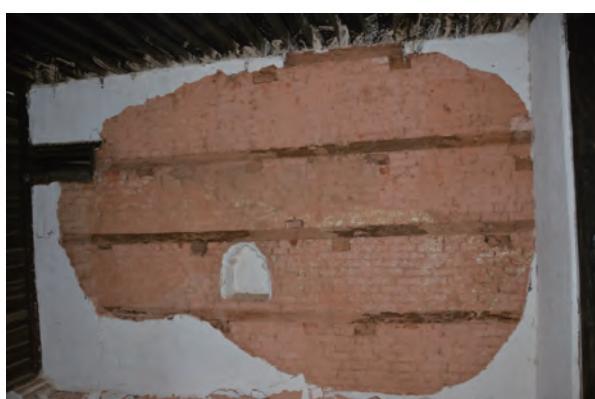
Fig.2-14 Some timber was exposed from inside the wall
### (9) Kirtipur

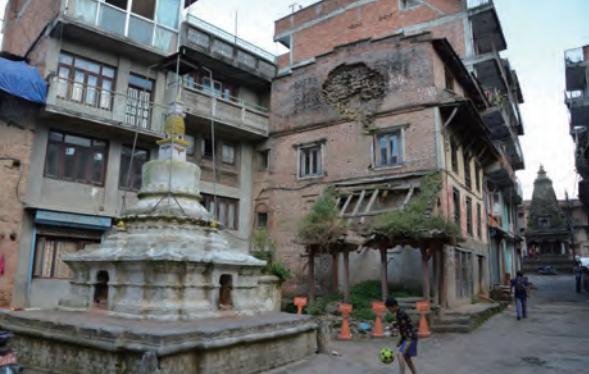
Kirtipur suffered relatively slight damage, because the tradition says that the town was established on a large bedrock. Conspicuous damage was not seen in the main historical buildings, including Bagh Bhairab, in the center of the old city. Although the city was surrounded by new buildings, there were still many historical buildings in the old city, and the former fortified cityscape was preserved. Therefore, it remains a very valuable cultural heritage site. However, little emergency aid reached Kirtipur because there were no earthquake victims here.

Fig.2-16 Damage situation in Kirtipur

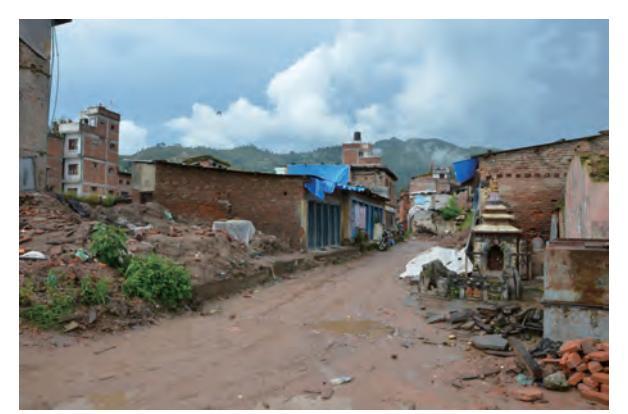
Fig.2-17 Damage situation in Sankhu

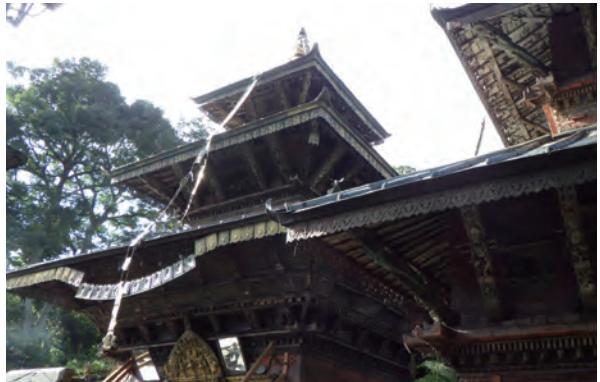
Vajrayogini Temple located on the hillside north of the town is an important Buddhist temple, being the second older temple in Kathmandu following Swayanbhunath. An inclination was observed in the main mortuary hall, which might be attributable to differential settlements caused by the imbalance of the original strength of the ground. Some parts of the monastery quarters in the upper part of the temple were greatly damaged.

Fig.2-18 Vajrayogini temple

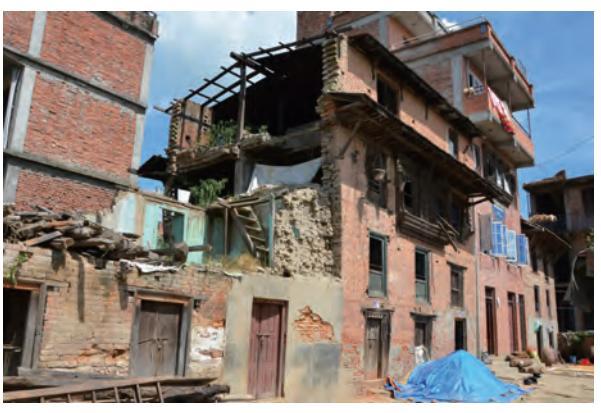
Fig.2-20 Damage situation of Khokana

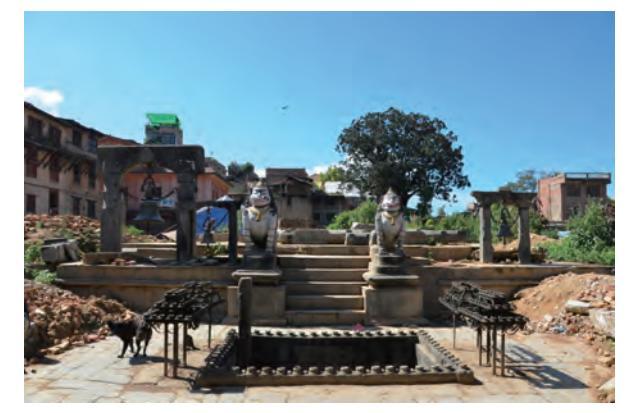
Fig.2-21 Collapsed temples in the center of Bungamati

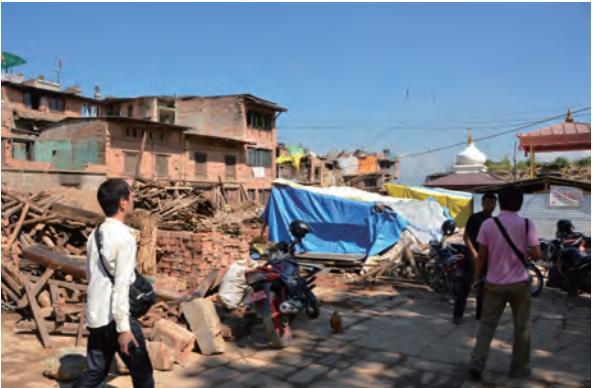
Fig.2-22 Damage situation of Bungamati

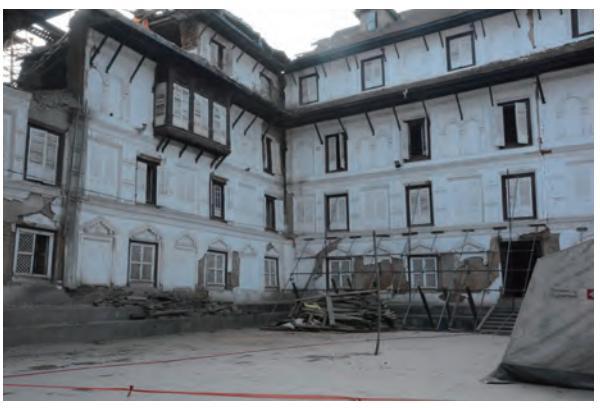
Damage situation of the south of Nasal Chok and Fig.2-25 Damage situation of inner walls of the Nasal Chok

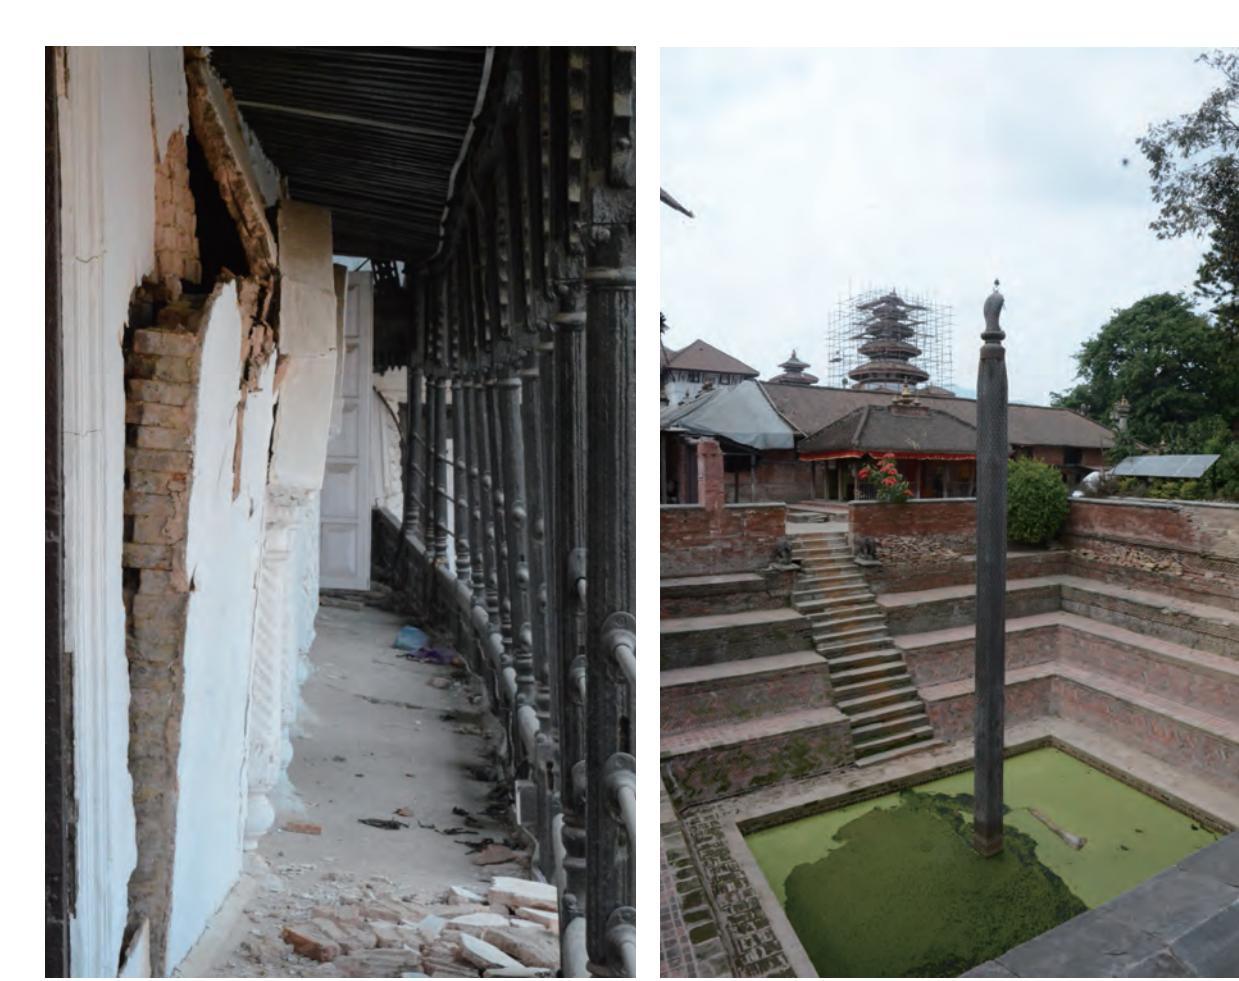
Fig.2-26 Damage situation at the veranda on the second floor of Mohan Chok Fig.2-27 Nagpukhu, East side of Hanumandhoka

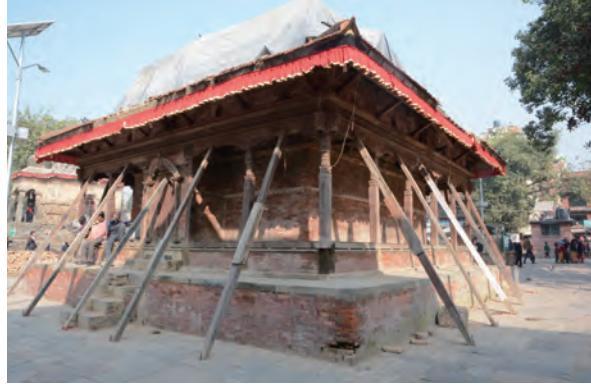
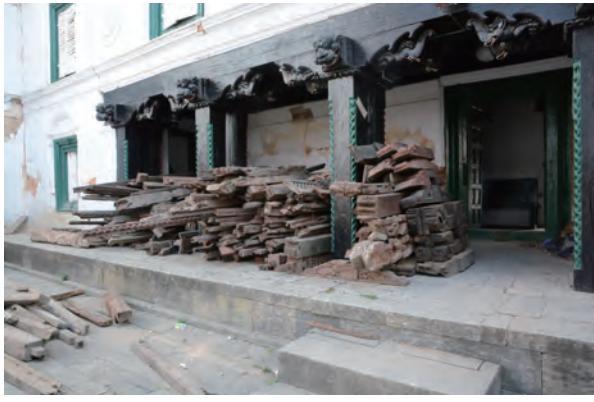
Fig.2-28 Kageshwar temple whose upper floor was Fig.2-29 Salvaged members compiled under the porch of Dakh Chok

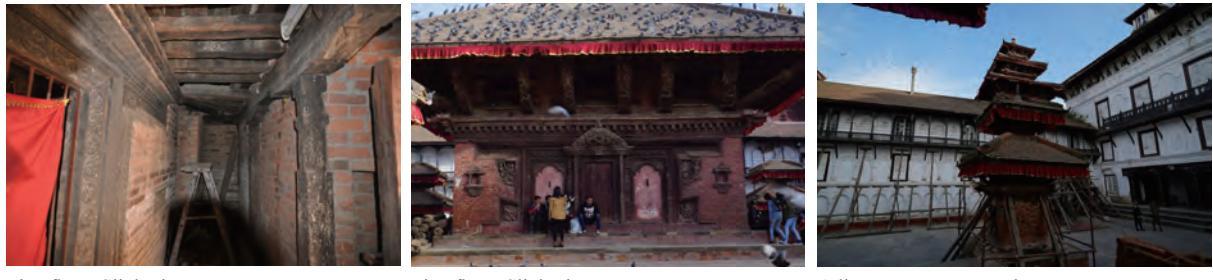
Second floor: Slight inside and outside wall Second floor: Slight inside wall damage damage

First floor: Slight damage

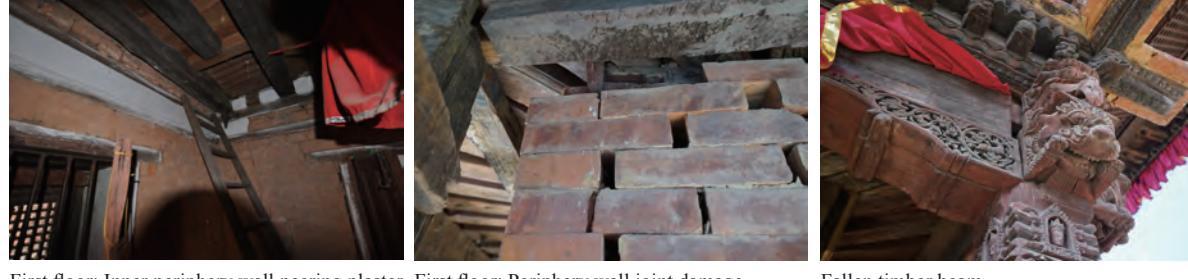
Second floor: Slight inner-periphery wall damage

First floor: Inner periphery wall peering plaster First floor: Periphery wall joint damage and joint damage

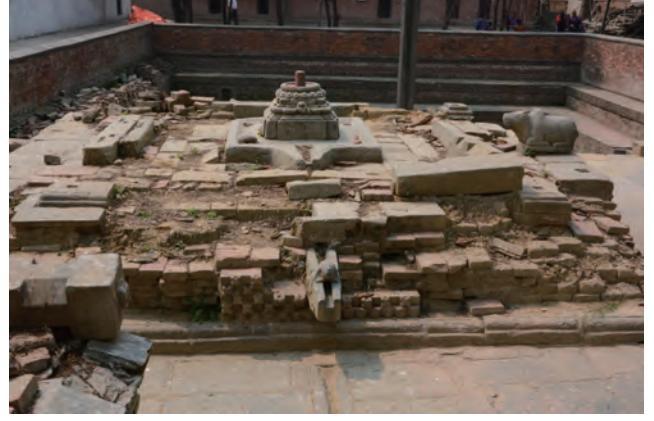
Fig.5-1 Foundation of collapsed Shiva Temple
