### 国際的な観点から見た木造建築遺産の保存

#### The Conservation of Wooden Built Heritage: An International Perspective

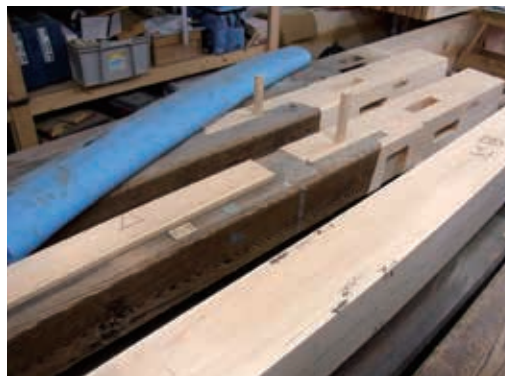
伝統的木工技術による古材の補修（日本）  
Repair with traditional carpentry techniques (Japan)

日本では、比較的統一した理念と技法のもとで木造建築遺産の保存修理が行われています。すなわち、修理の際に建造物の健全な部材は保持され、腐朽した部材は継木・矧木などの伝統的な木工技術によって補修され、部分的に取り替えられます。建造物の破損状況が著しい場合、一部または全体が一旦解体され、部材の補修・取り替えを行った上で再び組み直されます。さらに、各部材の歪および建造物全体の傾斜や不同沈下が修正され、構造体の本来の働きが取り戻されます。このような基本方針は国の文化遺産としての建造物の修理の当初から見られ、100年をかけてより実証的な修理方法へと発展してきました。現在、これは「標準的」な修理方法として国宝・重要文化財木造建造物に適用されています。また近年、特に修理に伴って行われる調査の綿密さ、木工技術の精度、修理記録の的確さなどの点において、国際的にも評価されるようになりました。

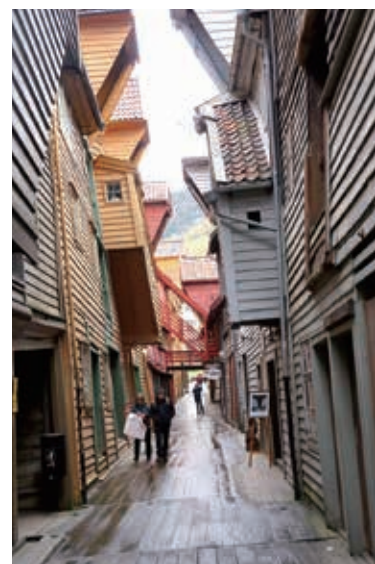
ベルゲンの街並み（ノルウェー）  
Townscape of Bergen (Norway)

しかし、海外の木造建築遺産の修理事例を見ると、日本と大きく異なる修理方法も適用されていることが確認できます。多くの事例では、部材の歪や建造物の傾斜が、「破損」ではなく、建造物の文化遺産としての価値を構成する重要な要素として認識されています。修理の際は構造的な安定性に直接影響を与えない歪・傾斜は修正せず、解体修理を避けて建造物を現状のまま保存することが原則とされます。ノルウェー・ベルゲンの校倉造り木造倉庫群の修理事業はこの修理方法の代表的な一例として挙げられます。軟弱な地盤に立つこれらの建造物には傾斜や不陸が目立ち、特徴的な街並みを構成しています。現在進行中の修理事業では、建造物を揚家し、伝統的な木工技術による部材の補修が行われていますが、原則的には解体を避けて建造物が傾いたまま維持されています。

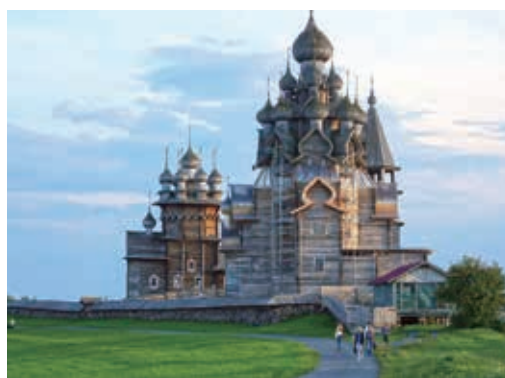
キジ島・変容の教会の修理（ロシア）  
Repair of the Church of the Transfiguration, Kizhi (Russia)

一方、日本と類似する修理方法が適用されている事例も確認できます。ロシア・キジ島の「変容の教会」では、深刻化する破損状況に応じて、1980年代に建造物内に鉄骨造の補強フレームが建て込まれました。しかし、このことによって建造物への出入りができなくなりました。様々な修理方法が検討されましたが、最終的に建造物の各層を下から順番に解体し、部材の補修とすべての歪・傾斜の修正を行った上で組み直す、という修理方法が採用されました。建造物を一挙にではなく、層ごとに解体する点は異なりますが、最終的には日本の解体修理と同じ方法です。
