### 煉瓦造建造物の建設技法の保存

#### Conservation of Construction Techniques for Brick Buildings

(保存科学研究センター・石田真弥)

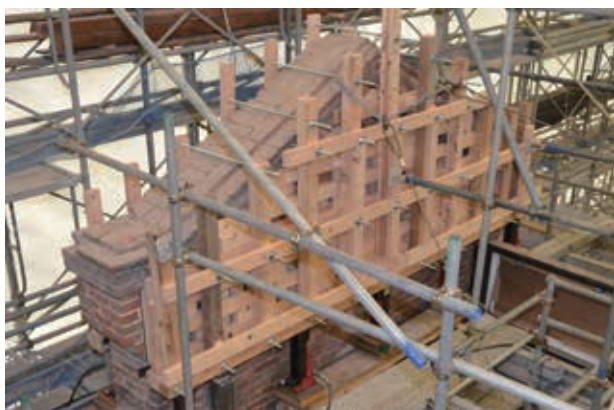
写真1：シャトーカミヤ旧醸造場施設の据え直しをする亀裂壁面の養生（出典：重要文化財シャトーカミヤ旧醸造場施設保存修理工事（災害復旧）報告書）

Photo 1: Restoration of cracked walls of the Chateau Kamiya Former Winery to be re-installed (Source: Report of the restoration and conservation work (disaster recovery) for the Chateau Kamiya Former Winery as an important cultural property)

しかし、近年の保存修理工事では、材料や煉瓦積み技法を保存した事例が増加しています。凍結破砕などが発生していた旧手宮鉄道施設機関車庫三号（小樽市）では、劣化した煉瓦を差し替えるだけではなく、凍結破砕の原因となっていた水の侵入を防ぐため、一層分の目地を止水材に取り替えるなどの改善工事が行われ、材料の保存がはかられました。さらに、東日本大震災で壁面部分に亀裂が入ったシャトーカミヤ旧醸造場施設（牛久市）（写真1）では、当初の煉瓦壁面を積み直すことなく最大限保存するため、亀裂の入った壁面上部を揚屋し、亀裂箇所を修復した後、据え直されました。

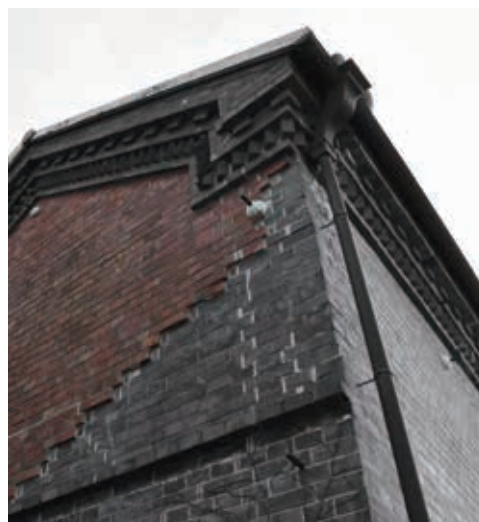
写真2：旧野村さとう店煉瓦蔵の保存修理後の煉瓦壁面（筆者：ズレた壁面を強調するため色加工）

Photo 2: Brick walls of the former Nomura Sugar Store Brick Warehouse after the restoration and conservation (Note: To highlight the misaligned walls, the color is specially processed.)

また、旧野村さとう店煉瓦蔵（土浦市）（写真2）でも、地震により発生した亀裂に対して積み直しを行わず、隙間が生じた部分に新たに煉瓦を差し込み、亀裂の入った壁面同士を縫い合わせるように金属棒を挿入する補強が行われています。そのため、修理後の壁面は亀裂箇所ごとにズレたまま固定されていますが、当初の壁面の大部分が保存されました。このズレた壁面の保存は震災遺構の保存としても大きな意味を持っています。
