カトマンズ・ハヌマンドカ王宮内シヴァ寺院の発掘調査

Excavation of Shiva Temple in Hanumandhoka Palace, Kathmandu

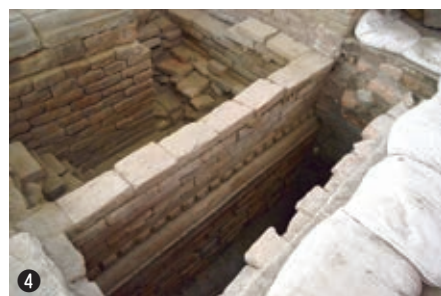
一方、寺院北西部の調査区では、地中に埋没したもう一つの基壇（下成基壇）が出土しました（写真4）。この下成基壇は、上部構造が載る地表部の基壇よりもおよそ50センチメートル外側を囲うように造られており、現地地表下1メートルほどの深さから立ち上がっていました。下成基壇は「ダチアパ」と呼ばれる化粧煉瓦で構成されており、本来は人の目に触れることを前提として造られたと考えられます。

④北西部の調査区より出土した下成基壇

Lower podium unearthed at the survey zone in the North-West area.

Meanwhile, another foundation buried in the ground (lower podium) was unearthed (Photo 4) in the survey zone to the North-West of the temple. This lower podium rising up from a depth of 100 cm below the surface is built approximately 50 cm outside of and encircling the ground surface foundation on which the upper structure is placed. The lower podium is composed of decorative brick called *dachiapa* bricks which are thought to have been originally built presupposing they would be seen by people.
