## Method for cleaning epiphytes on stone monuments

Masayuki Morii \* and Wataru Kawanobe

### Abstract

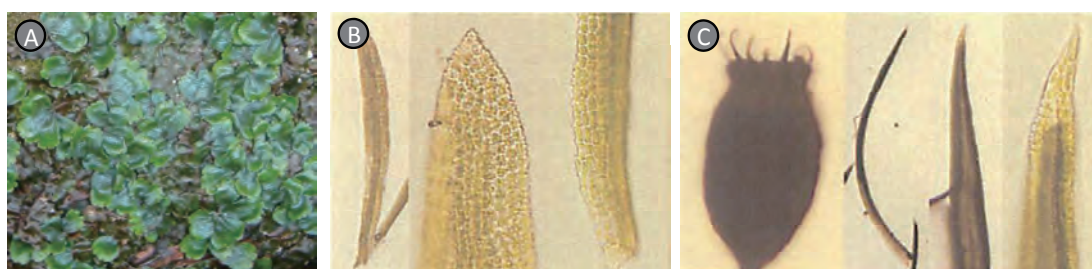
Fig.3 Identified moss: a) *Conocephalum conicum* (L.) Dum.; b) *Gymnostomum aeruginosum*; c) *Weissia longidens* Card.

Furthermore, among the epiphytes around Dainichi Nyorai Zazo, bryophytes were identified by visual and microscopic observations (specimen identification by Masanobu Higuchi). The results of identification are provided on Table 1 and Figure 3. During sampling, growth of epiphytes, possibly moss, was observed under the bryophytes that had been sampled.

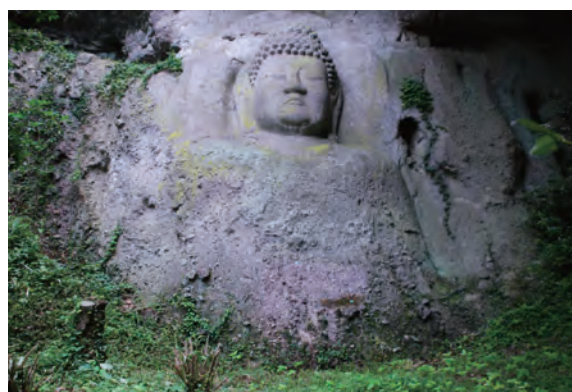
Fig.4 Dainichi Nyorai image of the Kumano Stone Buddha in 2007

the condition of conservation of the stone Buddha images was thought to be good even today, 30 years after the treatment (Fujimoto 2006). However, dark yellow epiphytes had grown over a large area extending from the head to the chest of the Dainichi Nyorai image. These had raised problems in appreciating the images, causing complaints from visitors (Fig. 4).

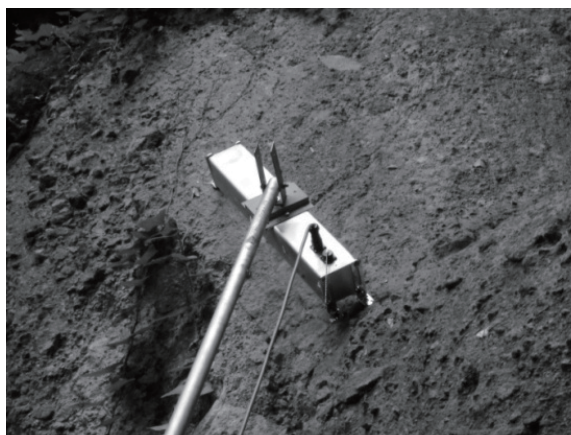
Fig.5 UV-C irradiating system

Thus, the authors considered irradiating UV ray with wavelength of approximately 254nm, which will cause great damage to the epiphytes, in order to dry

them and to remove them in that condition. For this purpose, the authors developed a UV-C irradiating system (Fig. 5). Safety measures, such as limiting the hours of irradiation and installing a cover around each irradiation device, were also taken so that visitors would not directly look at the UV lamp.

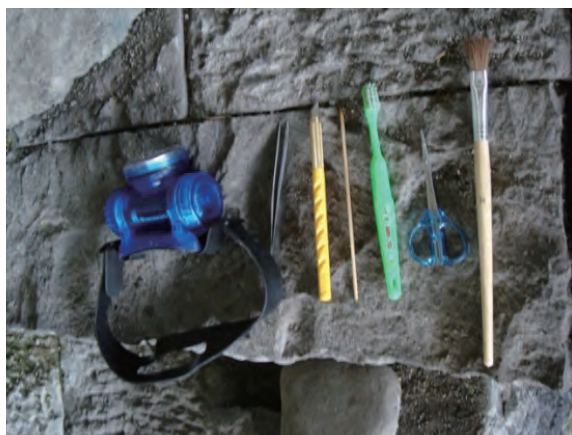
Fig.6 Tools for cleaning epiphytes

used to remove the dried epiphytes (Fig. 6). It was quite easy to brush off the moss, lichens and blue-green algae. However, since bryophytes like *Conocephalum conicum* were attached very firmly to the wall surface, a pair of tweezers was used to pick the fronds so as not to damage the stone surface and rhizoids were cut off with a pair of scissors.

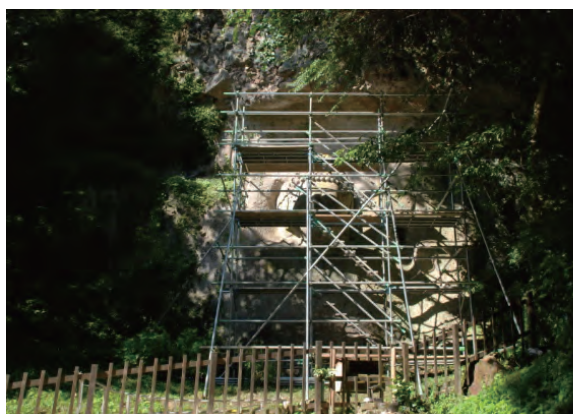
Fig.8 Scaffold at Kumano Stone Buddha

Since the Dainichi Nyorai image is extremely large, it being 6.8m high, and is located within a historic site, care was taken in installing the scaffold so that it would not fall on the side of the image; stakes were not used for digging (Fig. 8). Investigation was made after installing the scaffold and it was decided that only the removal of epiphytes and water-repellent treatment to prevent future growth would be conducted once UV-C had been irradiated.

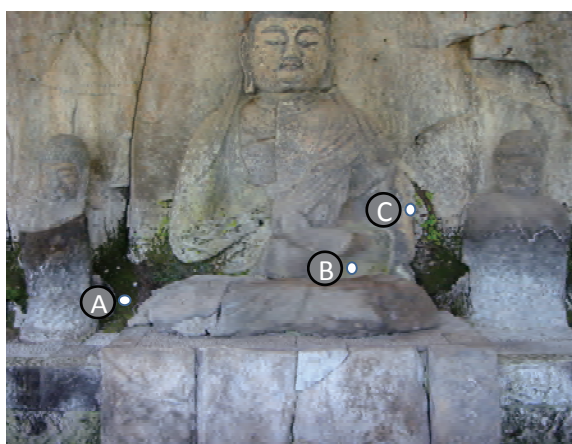
Fig.9 Monitoring points for color change

treatment, a color spectrometer (MINOLTA CG-400) was used in addition to visual inspection and photographing (Measuring points: Fig. 9; Results: Table 5 and Fig. 10). At point A where there was a growth of *Conocephalum conicum*, there was no large

change in a\* or b\* value after removal; the values also confirmed that the growth of moss had been controlled. At point B, which had appeared yellowish green before irradiation because of the growth of blue-green algae, the color had become lighter with irradiation; it was confirmed that the yellowish green color would return with time. At point C, where there was some cream color remaining, UV-C was irradiated indirectly but there was no change in the measured value; it was confirmed that UV-C irradiation had no effect on the pigments, as had been shown in a laboratory test (Kuchitsu 2001).

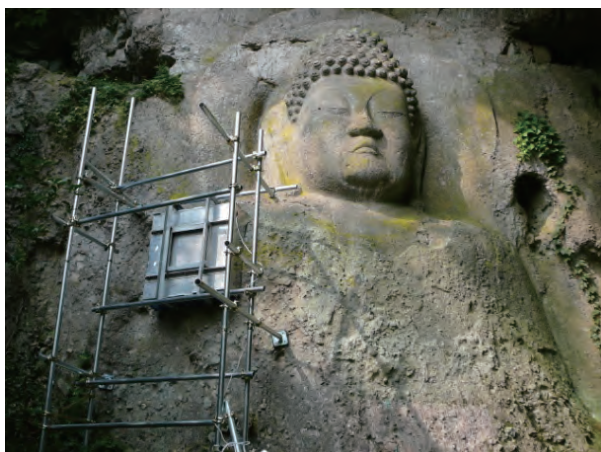
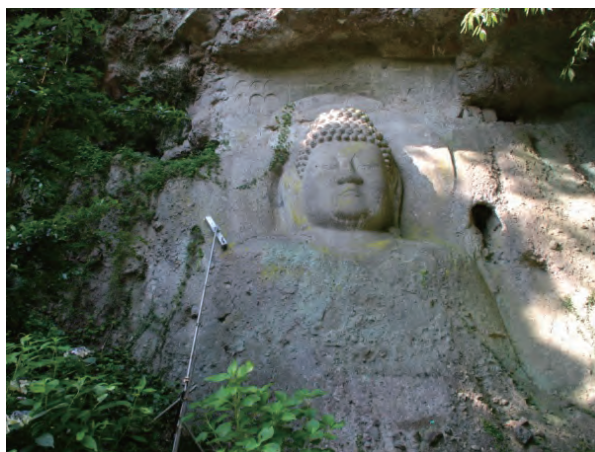
Fig.11 On-site testing of UV-C irradiation at Kumano Stone Buddha)

As an on-site testing, UV-C was irradiated from July 7 to 15, 2008 on the right shoulder of the Dainichi Nyorai image (Fig. 11). After that, monitoring was conducted visually, by photographing and with a color spectrometer (MINOLTA CM-2600d). In the

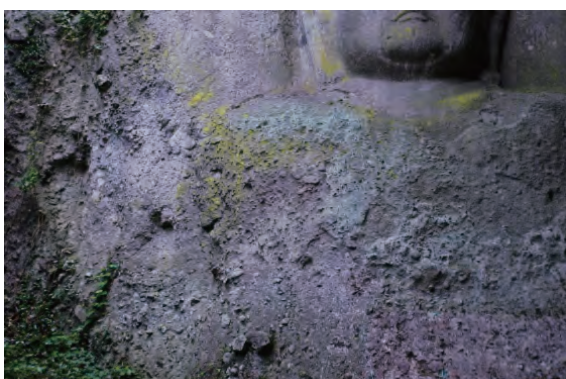
Fig.12 Surface after cleaning

first on-site testing, golden lichens were found remaining (Fig. 12), but at the end of September 2007, 2 months after irradiation, the dark yellow color had disappeared from the irradiated area and the rock surface could be confirmed (Fig. 13). At this point, it

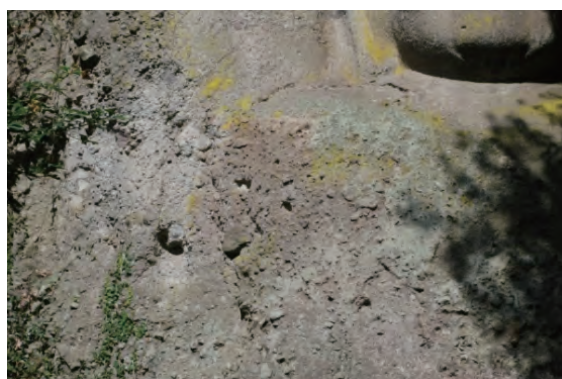
Fig.13 Surface after 2 months

was assumed that unlike the bryophytes that dry immediately after irradiation and become grey, the effect became apparent sometime after irradiation. In the on-site testing that followed, 5 places were chosen for measuring, based on the shape of the irradiating

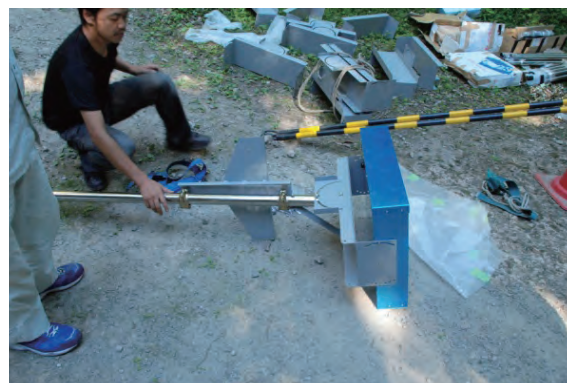
Fig.16 UV-C irradiating system for Kumano Stone Buddha

As a result of on-site testing, cleaning was done in 2009 as a part of conservation work. Since Kumano Stone Buddha today is in an outdoor environment, a waterproof UV-C irradiating system (Ginza Sakura Co. Ltd., Fig. 16) was used. It is possible to install 5 standard 40W UV germicidal lamps with 19.8W UV output. UV-C irradiation intensity 30cm away from a lamp is  $0.38\text{mW/cm}^2$ . Moreover, since the surface of the Dainichi Nyorai image is deeply carved, the irradiation device was adjusted so that it would move along the curving surface (Fig. 17).

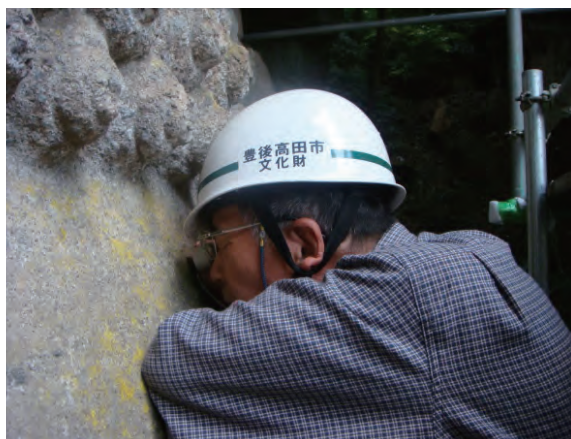
Fig.18 Observation of epiphytes at Kumano Stone Buddha

on the scaffold and the restriction of electric output. Irradiating points were changed and the entire Dainichi Nyorai image and the lower portion of the Fudomyo-o image were irradiated in approximately 9 weeks. Furthermore, within that time, the condition of the golden lichens after UV-C irradiation was observed visually (Figs. 18 and 19).

Visual observation was conducted a month after irradiation, when irradiation had been completed (Moon et al 2008). As has already been mentioned, the dark yellow color did not disappear immediately after irradiation. However, visual observation showed that in places like the face, irradiation was successful and that lichens had been killed. Nevertheless, in places like the border between the image and the cliff surface or between spirals, lichens still remained. Thus, the angle of the devices was changed and irradiation was done again.

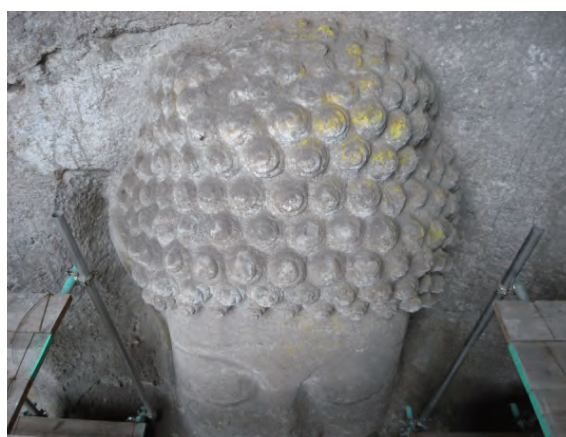
Fig.22 Before cleaning epiphytes

of the stone surface. As a result, it was possible to completely remove the golden lichens (Figs. 21 and 22).
