# Technical Assistance for the Protection of Damaged Cultural Heritage in Nepal

*Project Report*

May 2017

Tokyo National Research Institute for Cultural Properties

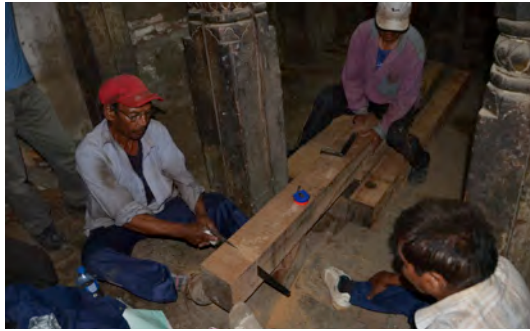
Fig.2-2-5 The stabilisation work of inner space on the first storey (the ground floor) below Aganchen Temple: Wood-processing work (June 2016)

1. Wooden frames were installed and fixed inside each room on the lower storeys of Aganchen Temple in order to prevent further distortion of the structure.
2. Steel pipes were installed to support the outer wall at the levels of floor joists, from the west side of the west wing of Mohan Chok, in order to prevent the collapse of the outer wall.
3. A metal protective mesh was placed in order to prevent the bricks or the tiles from the damaged walls or the roofs from falling on pedestrians passing through Hanuman gate and worshippers to the Hanuman statue.

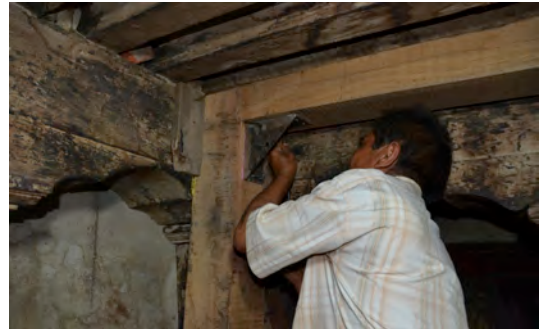
Fig.2-2-6 The stabilisation work of inner space the first storey below Aganchen Temple: Metal fitting installation (June 2016)

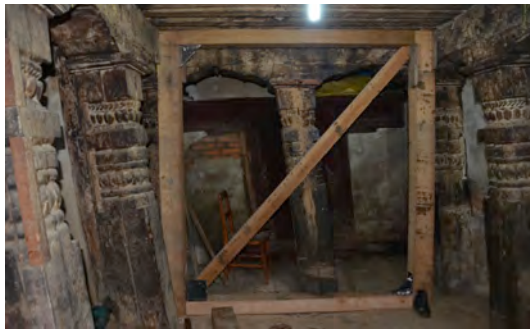
Fig.2-2-7 The stabilisation work of inner space on the first storey below Aganchen Temple: Installation of wooden frame (June 2016)

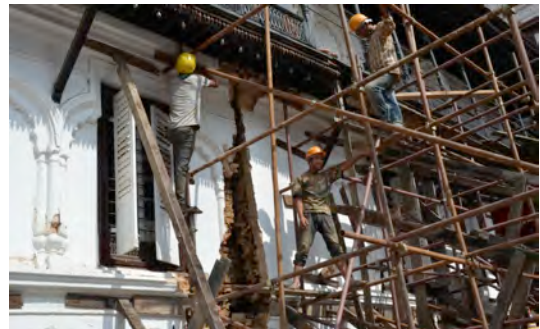
Fig.2-2-8 The stabilisation work of the exterior below Aganchen Temple: Addition and replacement of steel pipes (June 2016)

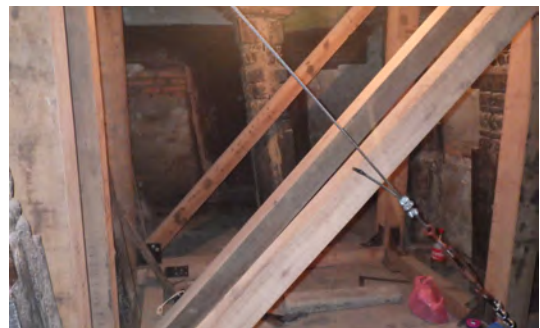
Fig.2-2-10 The stabilisation work of the inner space, below Aganchen Temple: Bracing with a wire and turnbuckles (September 2016)

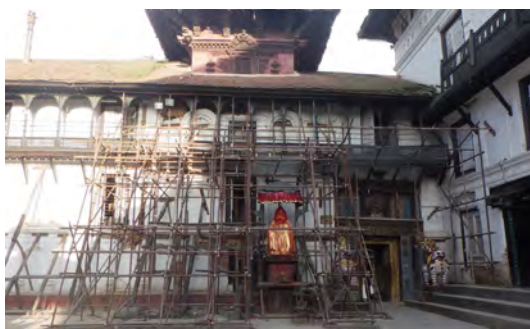
Fig.2-2-11 Completion of the stabilisation work: General view (September 2016)

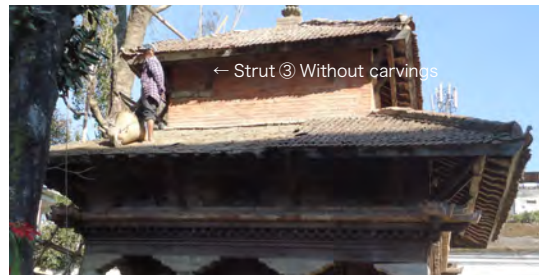
- ③ Unknown numbers: According to the pictures taken before the disaster of Gorkha Earthquake, 5 struts without carving are used at least on the south side and west side. As weathering had not appeared on brick walls of the upper storey, we considered that these members were added during the large-scale restoration modified into a relatively simple form in the later years (Fig.2-2-20).

Fig.2-2-20 Photograph of the Shiva Temple during dismantling of the roof (Taken on 12 Feb. 2014, provided by ERCO)

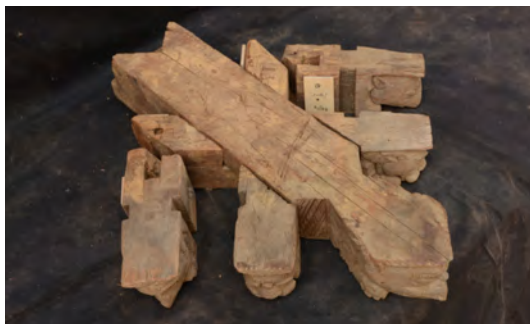
Fig.2-2-21 Partially assembled corner members ① with two types of chiseled marks

On the other hand, regarding the corner members, we found that the matching chiseled marks are placed on the top surface of the materials, which became a key to reassemble two complete sets partially (Fig.2-2-21, 22). A corner consists of 5 members basically, but each corner joint is different from another. On both corner sets of chiseled marks were placed on the diagonal member and at the end of the member located first from the corner. In the corner set of ①, the pattern marking that is different from the one at the end, made by a different tool appeared at the tip of the member located first from the corner. We know that members of both first and second from the corner are set into the diagonal member with a mitre butt joint in the corner set of ①. There are 7 in total members same as the one located at first from the corner, among which two pieces found in the set ② are the only ones that set not in a mitre joint. The reason for that is not known, however, this could be because of different craftsmanship at the same period, but also could be the works of different periods. This result is important evidence indicating that members of the same type were also processed for specific positions.

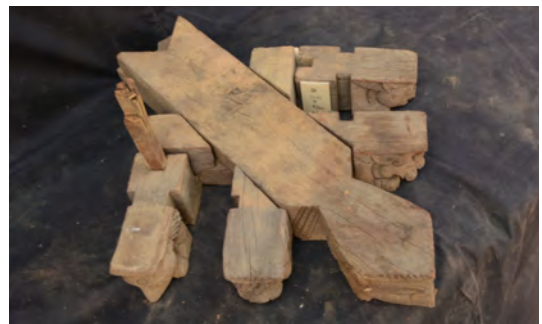
Fig.2-2-22 Partially assembled corner members ②

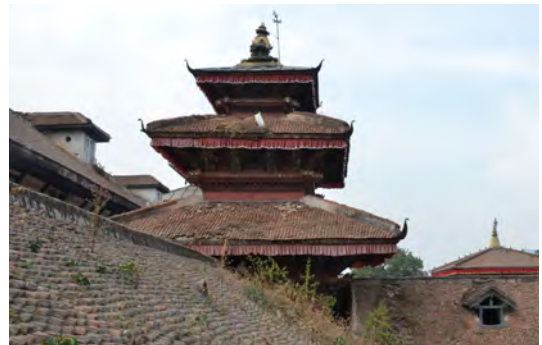
From the outside, there is no significant damage. Simple observation reveals inclination of the pinnacle on the top, displacement of roof tiles, and partial slackening of the brick joints around the corner wall. No significant inclination of the whole tower can be observed (Fig.3-1-11). We have not yet conducted an investigation of this tower entering inside due to religious reasons but this investigation is indispensable to evaluate its structural soundness accurately.

Fig.3-1-11 Three-tiered tower of Aganchen Temple (East side)

As for the three-tiered tower of Aganchen Temple, we decided to repair partially including the roof and some severely damaged parts without touching its main structure unless serious defects are revealed in the coming investigations. In order to correct the position of the building, we will detach the Temple once from the three-storey building below, which is the part right underneath the Temple, and move parallelly while restoration works take place in the section underneath and revert it back to reunite the building afterward.

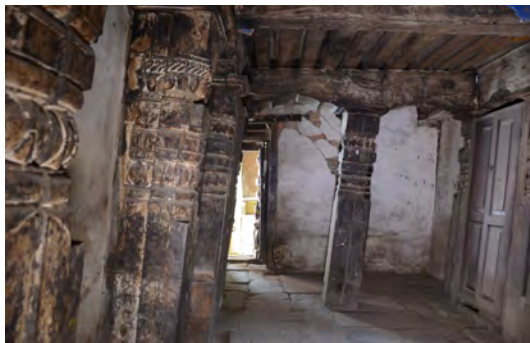
The entire section of the building is seriously inclined toward the west, and the inclination is more remarkable on the lower storeys. The degree of inclination reaches one-eighth on the first storey (Fig.3-1-12). The part of the outer western wall, around the openings on the first storey collapsed significantly and many cracks are evident on the upper storeys. Its northwest corner part is especially unstable with a significant gap in the wall surface (Fig.3-1-13). The emergency stabilisation work was conducted in the last fiscal year by installing pipe frames and the timber supports inside and outside of the building in order to prevent further inclination. In the balcony of the third storey, distortions occurred in many parts that are causing serious damage. (Fig.3-1-14) A gap of approximately 15cm has appeared between the east side of Aganchen Temple and the west end of the south wing of Mohan Chok at the attic space floor level, where both sections are supposed to be adjoined (Fig.3-1-15).

Fig.3-1-12 Interior view of the room on the first storey below Aganchen Temple

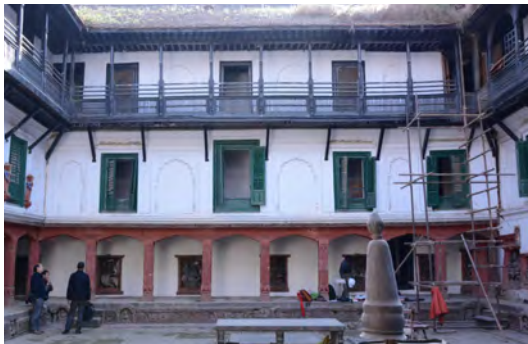
This is one of the buildings that earliest restoration and repairing works took place and finished after the Gorkha Earthquake but the colonnade of the corridor, at the northern side of the building on the first storey, incline towards the west looking from the inside of Mohan Chok (Fig.3-1-16). One pillar which did not exist originally has been added at the west end of the wooden beam above this colonnade so that the beam would not come out from the wall of the east side of the building below Aganchen Temple (Fig.3-1-17).

Fig.3-1-16 The colonnade at the north side of the south wing of Mohan Chok on the first storey

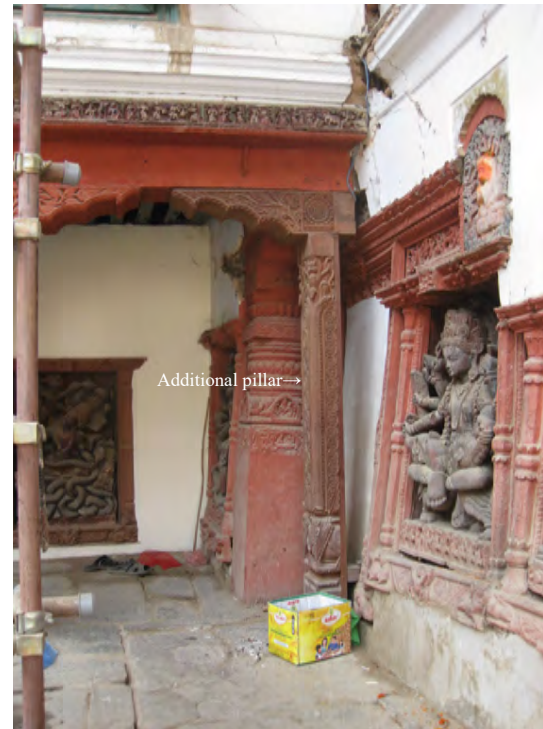
Fig.3-1-17 The column added at the western end of the north side of the south wing of Mohan Chok

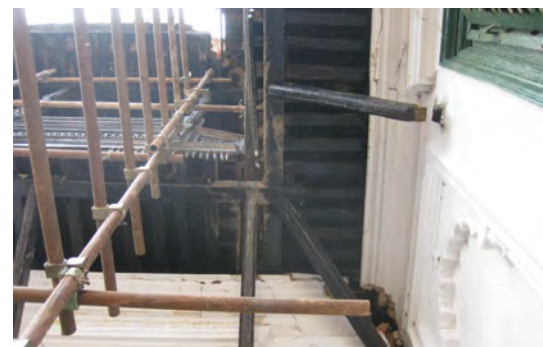
Both of the eastern and western walls are twisted along with the inclination of the building below Aganchen Temple and their angle of inclination is steeper on the south side (Fig.3-1-18). Many shear cracks are observed on the wall especially at the south end and there is a gap between the floor and the outer western wall on the third storey. Also, some struts of the east side balcony of the third storey facing the courtyard came off at the south end, suggesting that the balcony is in danger of collapse (Fig.3-1-19).

Fig.3-1-19 Balcony of the north side of south wing of Mohan Chok, view from below

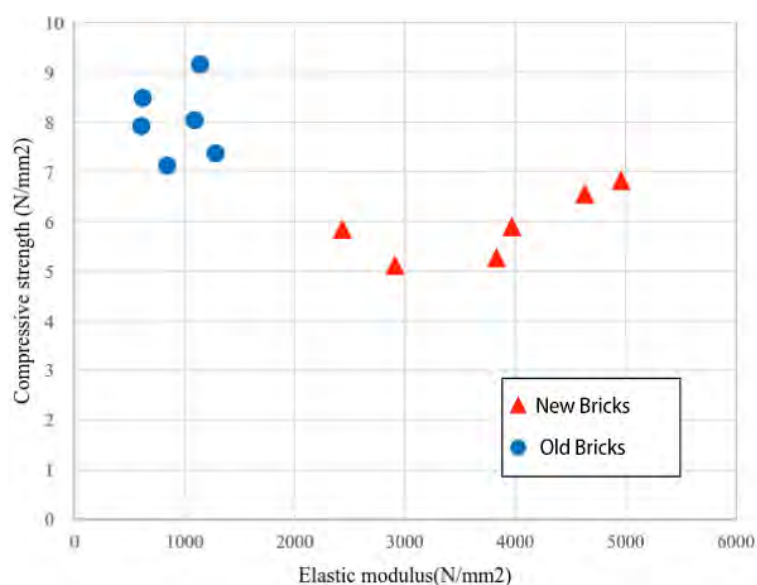
The elastic modulus of new bricks was higher than the old ones, while the compressive strength of the old bricks was higher than the new ones (Fig.3-2-1).

Fig.3-2-1 Compressive strength- elastic modulus graph (red triangle: new bricks, blue circle: old bricks)

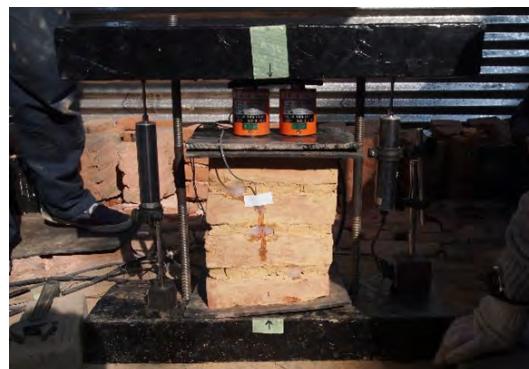
Fig.3-2-3 Compression test

After making brick prism specimens combining the above-mentioned 2 kinds of bricks and 4 kinds of mortar, a compression test (Fig.3-2-3) a diagonal compression test (Fig.3-2-4) and a bending test (Fig.3-2-5) were performed. The compressive strength of cement mortar masonry joint is the highest, followed by Yellow Mud, then by Lime Surkhi of the lesser sand ratio. However, the excessive strength of mortar joint caused the destruction mode in which bricks were damaged. Therefore, we need to pay attention for the choice of the material strength to be combined so that bricks will not be damaged. The results of the diagonal compression test vary widely and many specimens whose masonry joints would be peeled by the weight of the specimens themselves were observed. The results of bending test also vary widely but the bending tensile strength of masonry joint of cement mortar is the highest and Yellow Mud is the lowest. Between 2 kinds of Lime Surkhi, the bending tensile strength of the one of lesser sand ratio is higher.

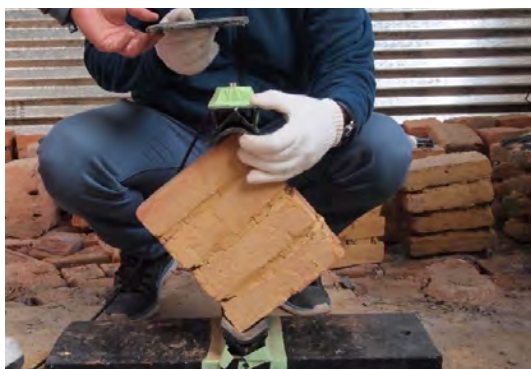
Fig.3-2-4 Diagonal compression test

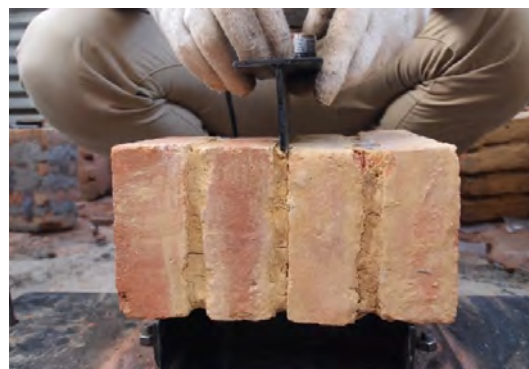
Fig.3-2-5 Bending test
