カンボジア・アンコール・タネイ寺院遺跡東門の修復 Restoration Work of the East Gate of Ta Nei Temple, Angkor, Cambodia

東門の修復 Restoration of the East Gate

カンボジア・アンコール・タネイ寺院遺跡東門の修復
担当:文化遺産国際協力センター保存計画研究室

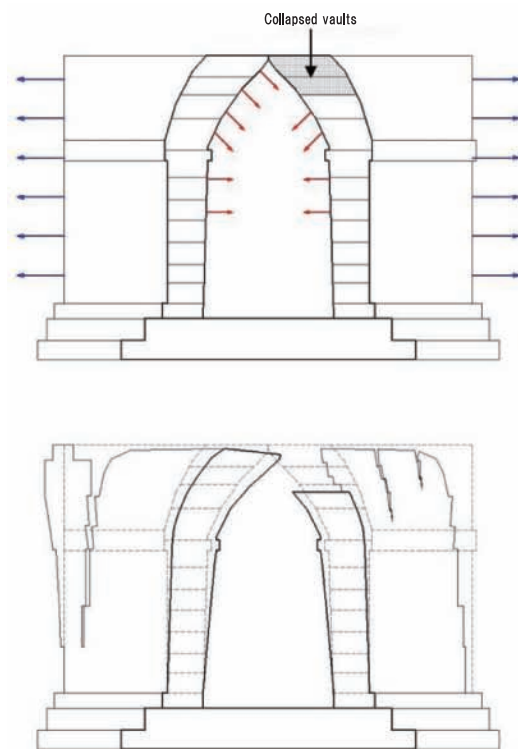
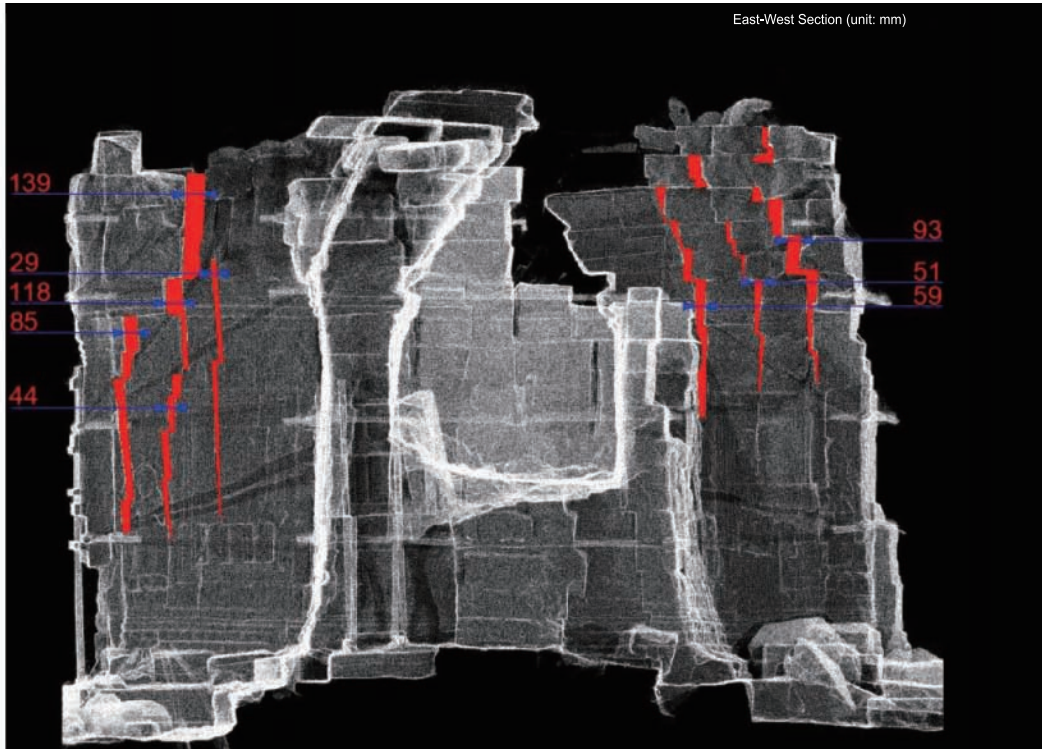
屋内堆積物の除去と必要な記録作業の完了後、10月16日から壁の解体に着手し、11月4日に壁最下層の石材(第16層)を残して解体を完了しました。解体に伴う調査を通して、樹根などが石材の目地に入り込み、建物が変形する一因となっている様子が確認できました。

After the cleaning and documentation works, dismantlement of the wall was started on October 16 and was completed on November 4 leaving the lowest layer of the wall (Layer 16). It was confirmed during this process that tree roots penetrating into joints between stones had caused the building deformation.

上： 屋根の解体作業
中左：壁の解体作業
中右：基礎構造の発掘調査と地盤強度試験
下： ボールカメラを用いた写真測量

Above: Dismantlement of the roof structure
Middle left: Dismantlement of the wall structure
Middle right: Archaeological research and soil testing of foundation structure
Below: Photogrammetry with high pole camera
