# Project for Investigation of Damage Situation of Cultural Heritage in Nepal

Project Report

National Research Institute for Cultural Properties, Tokyo

2016

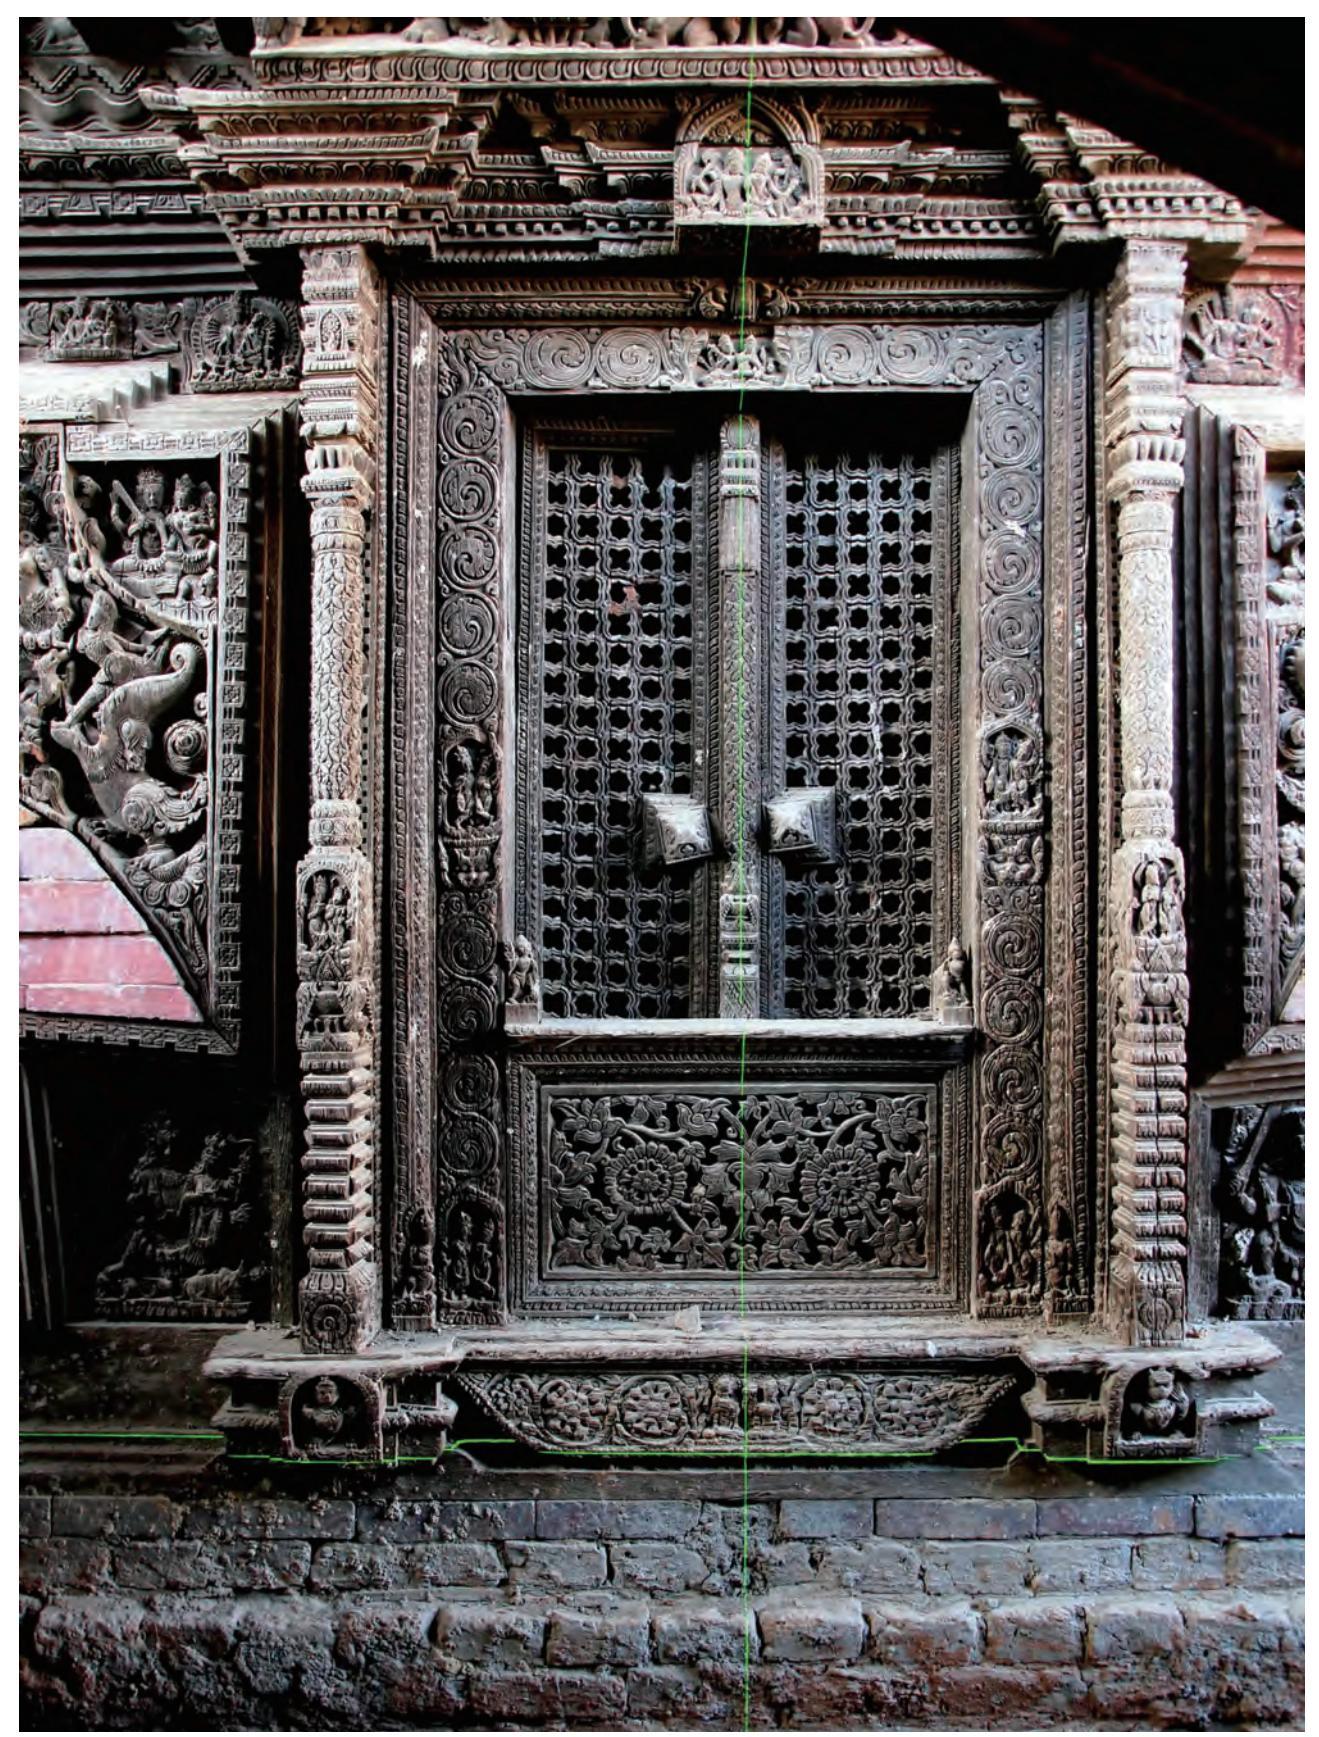
Frontispiece 1: Aganchen Temple, first storey, east side, 02 Dec. 2015

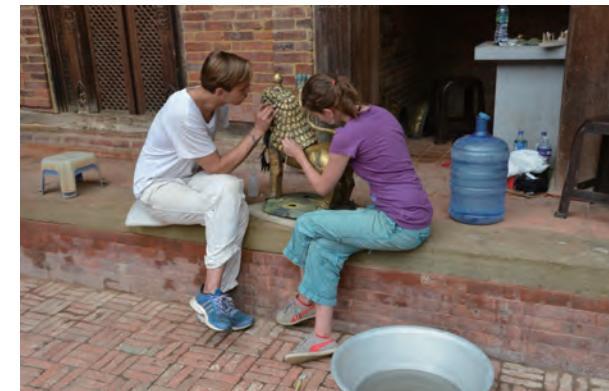
Fig.2-4 Restoring damaged statues

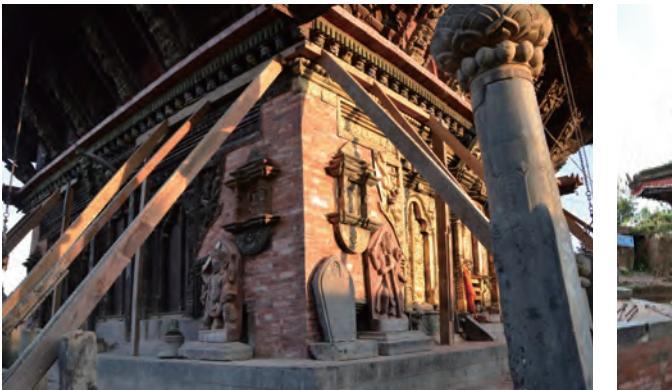
Fig.2-7 Changu Narayan

This Hindu temple built on the northern hill of Bhaktapur showed massive damaged. The upper layer of the two-storey corridor surrounding the main temple of the two-storey tower of Changu Narayan collapsed completely, and only the lower layer remained. The main temple and small tower of Kileshwar Mahadev located to its southwest were damaged at four corners of the lower layers and therefore became unstable, although the main temple was already restored in September. The removal of the temporal timber supports was questioned, because it seemed to be restored by simply laying collapsed bricks again. On the other hand, the wooden corner pole in the brick wall could be seen in the damaged part of the small tower, which might be valuable when studying construction techniques.

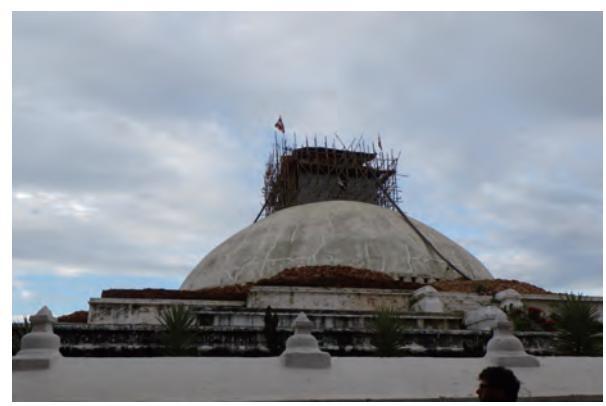
Remarkable damage was not seen on the outside of the great stupa of Boudhanath. The Buddhist monasteries around it were only slightly damaged. However, according to the DoA's investigation of the inside of the stupa, it was decided to repair the parasol-shaped roof above the flat top after removing it. The conservation work is currently underway.

Fig.2-12 The flat top that the parasol-shaped roof was removed

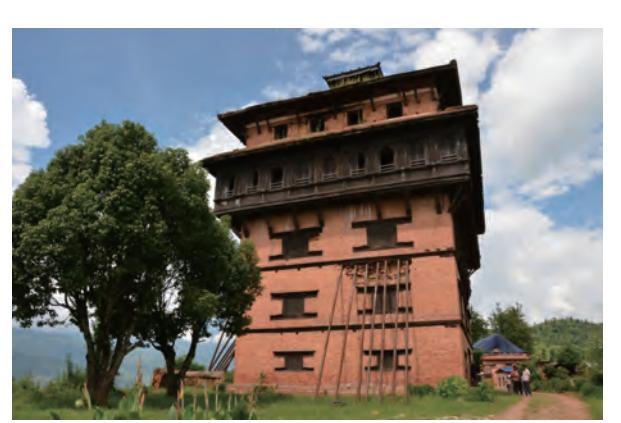
Fig.2-13 Sattale Durbar

Sattale Durbar was built in 1762, prior to Basantapur Bhawan in the Hanumandhoka royal palace, and both structures have many commonalities. This seven-storey palace mainly showed damage in the upper layer, and the damage was similar to that in the Kathmandu royal palace. This building had been used as a museum until the earthquake under the DoA. It was repaired a few years earlier, and some signs of construction work could be seen on the timber. Plaster dropped from the surface of the inner walls during the earthquake, and some timber on the inside was exposed; these seemed appropriate places to investigate the construction. Two tower temples in the palace site were damaged so severely that the inner structure of the brick walls could be seen. The upper layer of the four-storey galat facing the royal palace was greatly damaged, and the third and fourth floors were already removed in September.

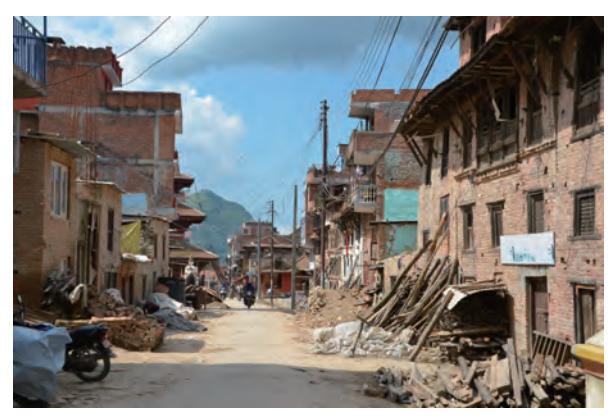
Fig.2-19 Main street in Khokana after Gorkha earthquake

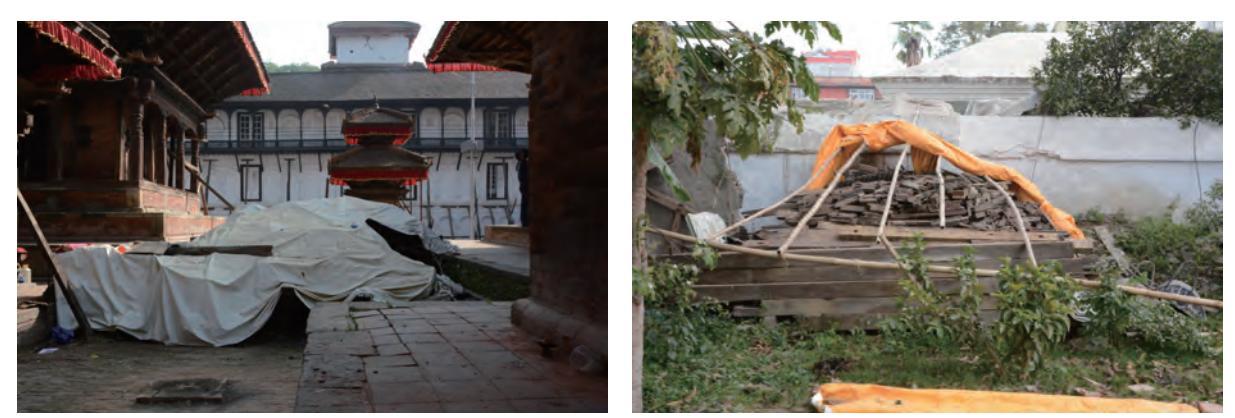
Fig.2-30 Salvaged members gathered next to Gopinath Fig.2-31 Salvaged Members from collapesed Shiva Temple

Because saving human life was prioritized immediately after the disaster, members from some adjacent collapsed buildings were collected and stored. However, these got mixed; they were piled up without sorting in the balconies in the lowers layer of the Chok or courtyard in the royal palace and on the street next to buildings away from the main routes in the square. According to an investigation of the stored timbers, collected timbers included only carved ones, and many undecorated long timbers such as members from the eaves were reused as temporal support timbers for inclined buildings. On the other hand, almost all timbers of the Shiva Temple east of Mul Chok, which collapsed completely, were collected at the same place without mixing with those of other buildings, because there are no other temples near the Shiva temple. It was judged that investigating and understanding the entire structure in a limited period were possible, because the temple was relatively small. Therefore, it was selected as the object for the arrangement, sorting, and storage of timbers (see Chapter 5).

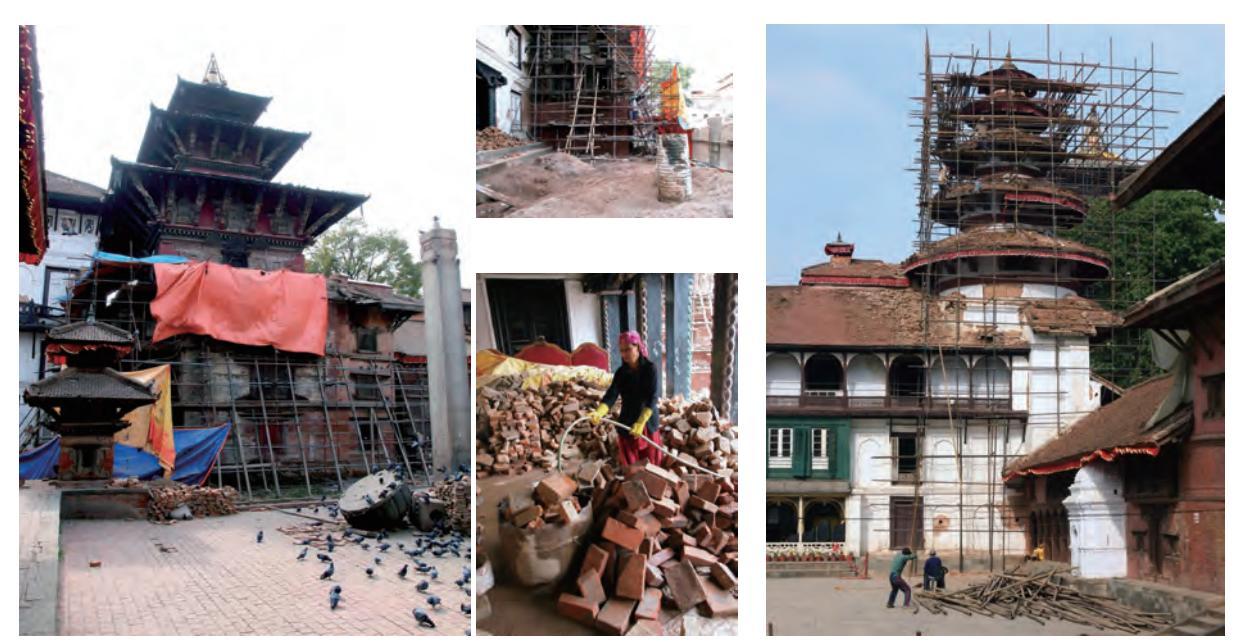
Two buildings are actually being repaired: Degu Tale (a large three-storied tower, hereafter referred to as Degu Tale Temple, Fig. 3-4) and Panchamukhi Hanuman Mandir (hereafter referred to as Panchamukhi Hanuman Temple, Fig. 3-5). Both of them are being repaired by DoA, and the work carried out seems to be conservation and repair of the damaged parts. While we want to express our admiration for the promptness with which they started, we have not obtained any information about the works being carried out. At first glance, in the case of Degu Tale Temple, the wall of the third storey (where the three-storey tower is standing) is being raised again (mainly the northeast corner of the east side) and the roof of the eaves is being rebuilt. The traditional practice of curing the bricks with water before piling them up again is being employed. White dots, presumably efflorescence, can be observed on the surface of the

already piled up bricks. The quality control of the materials is a matter of concern. The joints are made of mud mortar mixed with powder from bricks (it is unclear if there is lime in the mix) and there is an effort to achieve cohesion with the existing wall. In the case of Panchamukhi Hanuman Temple, the repair works consist of reroofing of the roof tiles, rebuilding the outer wall, and repairing wooden members. The leaning rooftop pinnacle  $(gaj\bar{u})$  has been dismounted and will presumably be reinstalled. We would like to watch if the extent of the repair reaches the south wing of Mohan Chok beneath. While the repair is an emergency one, we felt certain issues regarding the handling of old material and the fact that sound parts were being demolished in order to set the scaffolding. We were informed that the person in charge of the works is taking record pictures and videos. Nevertheless, there are many points we would like to check, such as the selection of materials employed in the repair, and the methodologies applied in the previous repair work. We hope that in the future the works advance in a coordinated way and information is shared.

Fig.3-4 Restoration of Degu Tale

Fig.3-5 Restoration of Panchamukhi Hanuman

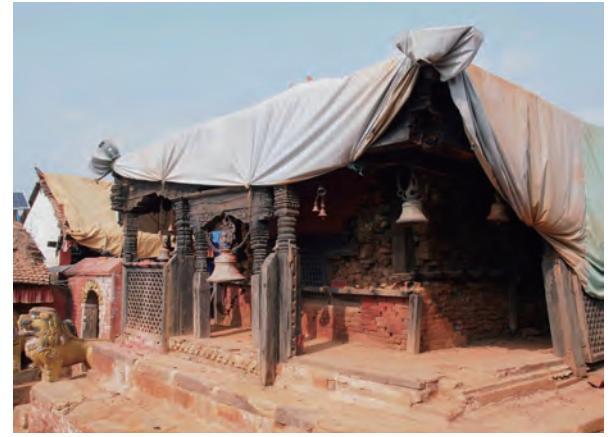
Bhairab Temple in Nuwakot is a small two-storey temple (Fig. 3-13, Fig. 3-14). As a result of the Gorkha Earthquake, the second storey was menacing to collapse and was dismantled. Currently, only the first storey can be observed.

Fig.3-14 Outside view of Bhairab Temple. The corner pillar has fallen down, but the building has not collapsed completely

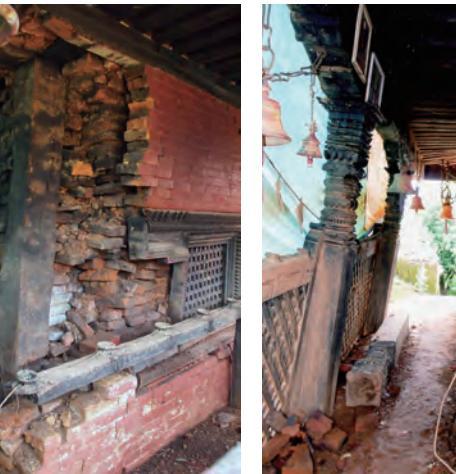
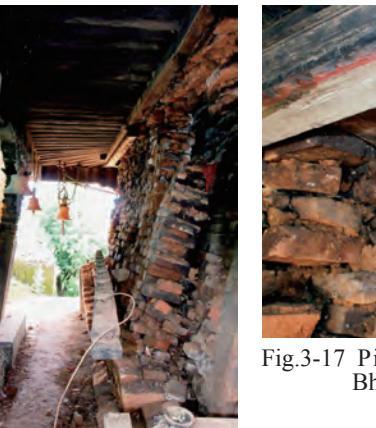
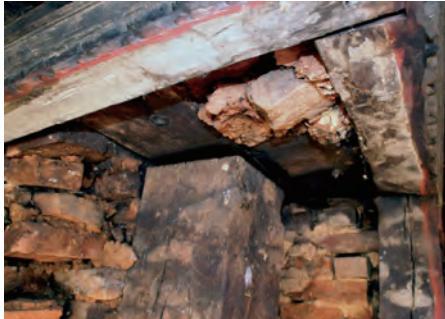
The First storey has a 500-600 mm wide brick wall on four sides. The earthquake damaged part of it, revealing timber pillars embedded inside. There is a 22 cm wide square pillar in each corner of the brick wall, and the distance between pillar centers is about 3.6 m in the east-west direction and 2.9 m in the north-south direction.

The brick wall covering the pillars to the south side is heavily damaged (Fig. 3-15) and the whole building has a residual deformation in the east-west direction (Fig. 3-16). The joints between bricks are thin and weak, and the brick wall cannot be expected to behave as a unity. Observing the joint between pillars and beams/purlins, it can be deduced that they are joined with short tenons (Fig. 3-17).

A large proportion of the horizontal seismic load is transferred to the high rigidity brick wall through the friction between the timber frame and the brick. Although the weak joints were the cause of the heavy damage, the timber frame may have worked stabilizing the brick wall as a fail-safe mechanism.

Pillar embedded into the wall, Bhairab Temple

Fig.3-15 the wall at the southwest corner

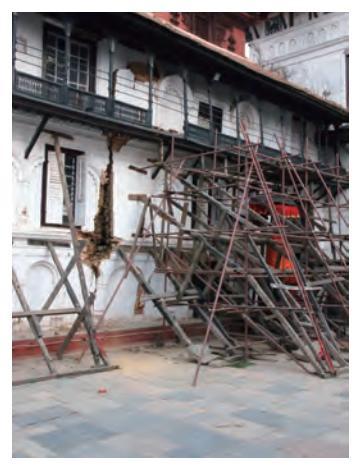
Aganchen Temple stands on top of the west wing of Mohan Chok, whose outer wall is significantly leaning towards the Darbar Square. The brick masonry wall has collapsed, pushing the bricks outwards (Fig. 3-22). The damage is especially notorious around the openings below Aganchen Temple and the connection with the west wing of Mohan Chok. The outer wall brick masonry and plasterwork are later additions, but it is possible that bricks from the original construction remain inside the wall. This is a fundamental factor in the assessment of the value of this building, and an important question in order to decide the repair policy. It is a point that should be clarified at the time of the execution of the repair.

Fig.3-22 Outer west wall below Aganchen Temple

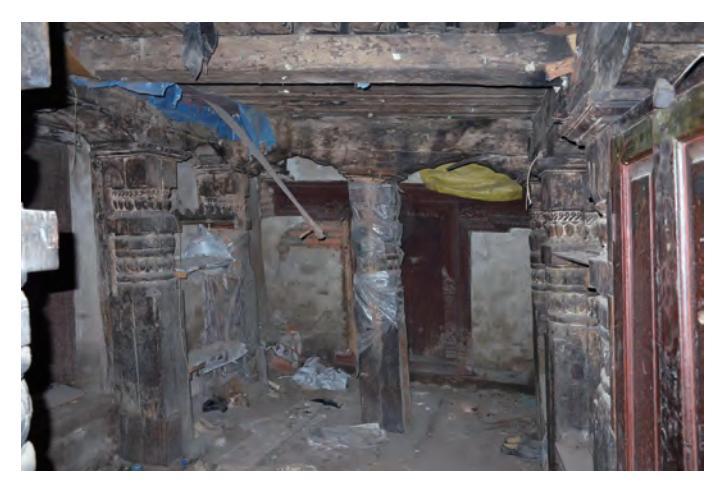
The space inside the first, second and third storey below Aganchen Temple (the southwest corner of the west wing of Mohan Chok) is occupied by rooms. There are 10 inner pillars with brackets on top supporting the beams and the load from above (Fig. 3-23). They are presumed to be later additions introduced as reinforcement (they will be hereafter referred to as "later pillars") and are notoriously leaning towards the square in all three storeys. In the first storey, the maximum leaning is 7 degrees to the west and 1 degree to the south. In the second storey the maximum leaning is 6 degrees to the west and 2 degrees to the north. In the third storey the maximum leaning is 1 degree to the west. The floor joists remain mostly horizontal.

However, as we discussed before the later pillars located below Aganchen Temple are significantly inclined, and the outer west wall (the southwest wall of the west wing of Mohan Chok) is heavily damaged, especially around the wall openings. A 15 cm gap has appeared between the lower level of Aganchen Temple and the southern wing of Mohan Chok at the level of the floor under the roof structure (4th storey) (Fig. 3-25). This means that the lower level of Aganchen Temple has experienced a significant horizontal displacement towards the square side to the west. Thus, there is no structural continuity between the west and south wings of Mohan Chok. The horizontal purlins of the 3rd storey are actually cut at the inside of the southwest corner (Fig. 3-26). In addition, the floor height is different at the lower level of Aganchen Temple and at the west and south wings. Thus, it seems that the lower level of Aganchen Temple was structurally independent already before the earthquake. This is the result of the renovation works carried out during the Rana period at the original Malla period buildings. Mohan Chok and Sundari Chok (the building neighboring to the south) were further altered afterwards. Together with further surveys of the inside of the tower, a survey of several features will be necessary in order to clarify the history of alterations and renovations of these buildings. Such features include, for example, the gap between the independent first-storey columns of the courtyard and the doors on the wall, and the gap between the depth of the eaves and the rainfall drainage ditch at the courtyard.

Fig.3-23 First storey below Aganchen Temple

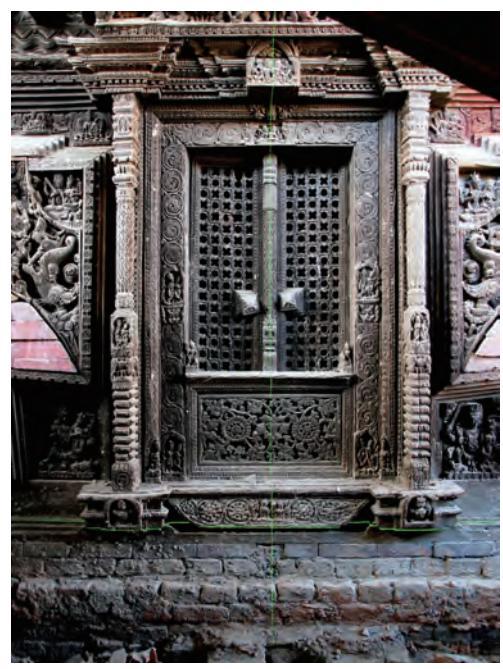
From the outside, there is no significant damage in the first storey of Aganchen Temple. A check with a laser level revealed that the body of the tower retains its horizontality and verticality (Fig.

3-24). The podium made of brick masonry that supports the body of the tower seems to be built on top of the floor joists, and it has sunk 6 cm at the south end of the east front side. The reason of this sinking is not clear; therefore we would like the condition of the terrain around Hanumandhoka Gate, which is neighboring to the south. The necessary emergency repair will have to give consideration to the structure of the foundation of Aganchen Temple. Here, we can point out that currently the body of the three-storey tower is stable.

Fig.3-24 Aganchen Temple, first storey, east side (the green laser beams show the horizontal and vertical directions)

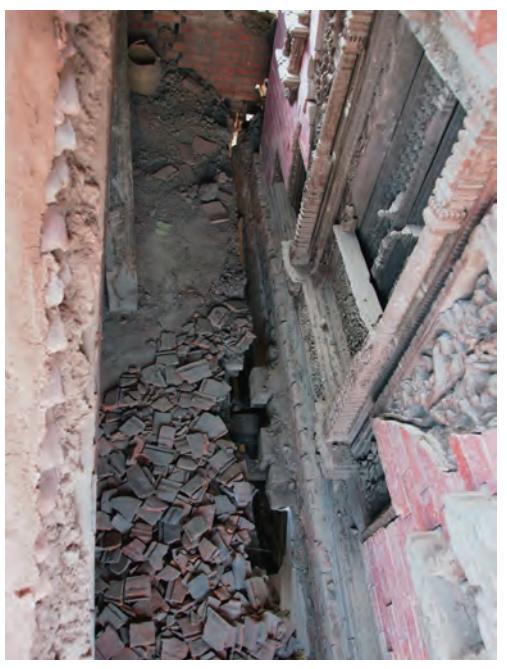
Fig.3-25 Gap between Aganchen Temple and the south wing of Mohan Chok (roof structure to the left, Aganchen Temple to the right)

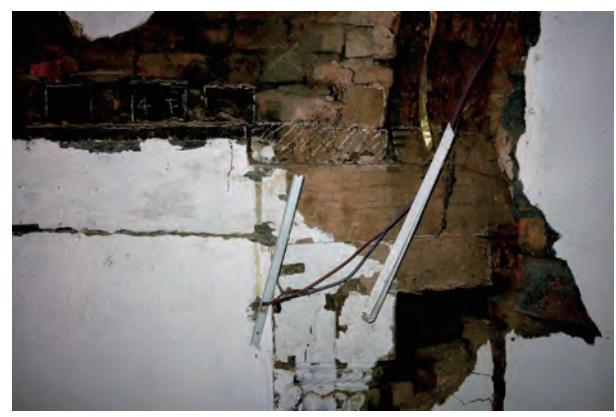
Fig.3-26 Traces on the purlins of Mohan Chok (3rd storey staircase, the white chalk marks show the section of the purlin that was cut off)

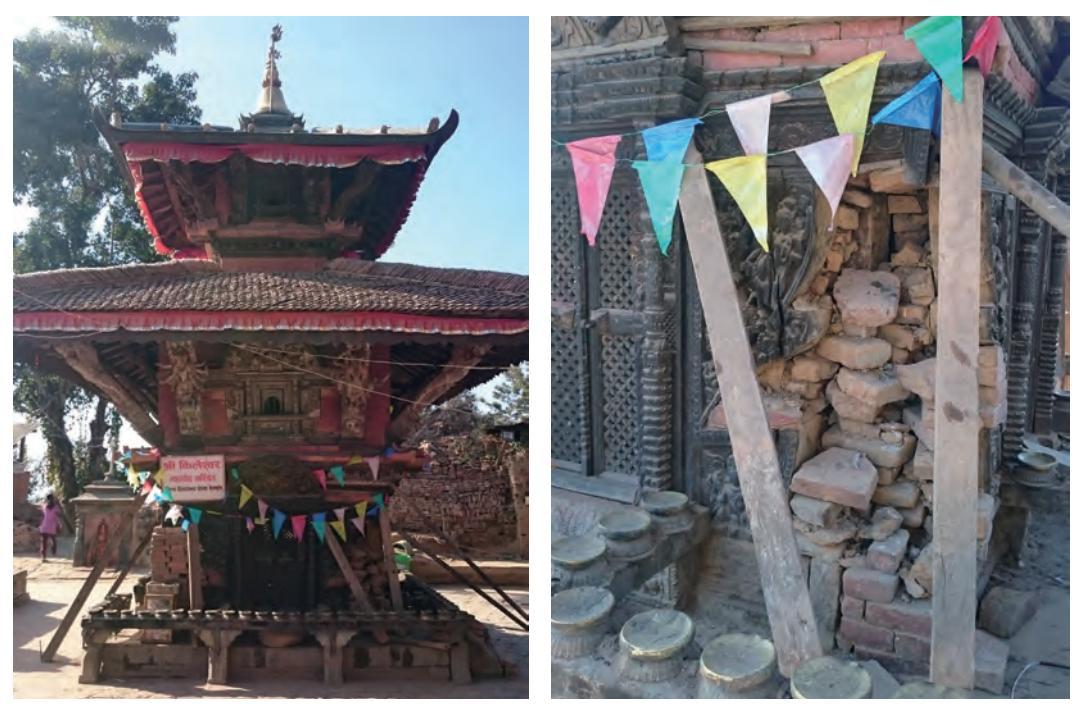
The pagoda structures in the Jagannath and Gopinath Temples were constructed using brick walls and timber frames. When considering a building's ability to resist its own weight, three letter classifications are used: (A) buildings primarily constructed with brick walls, (B) buildings primarily constructed with timber frames, and (C) buildings whose timber frames are built on brick walls. Among these classifications, type C buildings suffer fewer total building collapses because the timber frames resist their own weight despite collapse and loss of structural function of the brick walls. As shown in Fig. 4-4, the mixed structural system characteristics of the pagoda structures in Nepal likely contribute to their superior seismic performance.

Fig.4-4 Changu Narayan Temple structure saved from collapse by the timber column

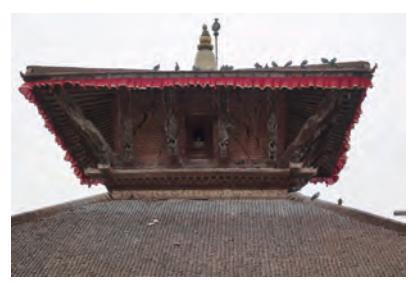
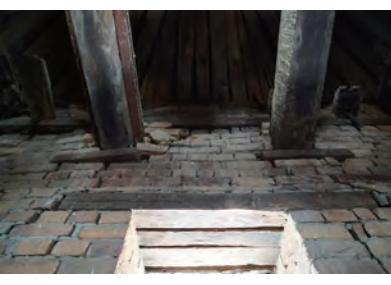
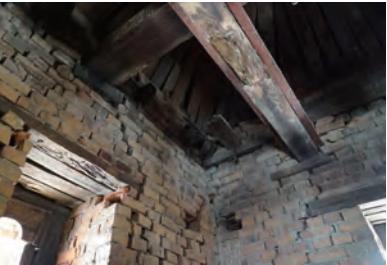
As shown in Fig. 4-5 damage to the Jagannath Temple following the Gorkha Earthquake was concentrated in the third (top) floor of the building. The shear failure of the brick walls appeared at the cutout for the roof beam. The shear failure was concentrated in the joint between bricks; failure of the brick itself was not observed.

Third (top) floor: Brick wall damage

Fig.4-5 Earthquake damage to Jagannath Temple

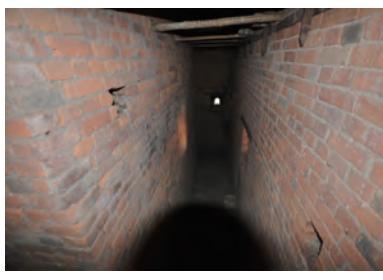
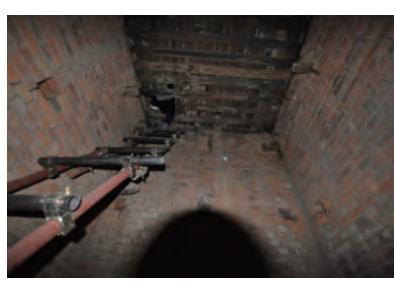
Third (top) floor: Crack at roof beam cut-out (1) Third (top) floor: Crack at roof beam cut-out (2)

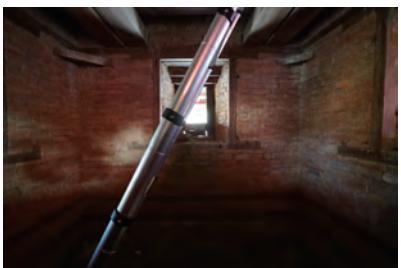
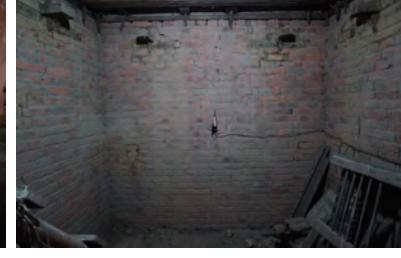
Prior to the Gorkha Earthquake, the Gopinath Temple was reinforced with a temporary column and knee brace as an emergency measure against the earthquake damage. The knee brace provided additional support at the east and south sides of the structure; residual deformation to the east or southeast direction was likely. As shown in Fig. 4-6, structural damage to the Gopinath Temple was concentrated in the first floor. Primary structural damage included collapsed brick wall joints, peeled inner wall plaster, and fallen timber beams at the periphery. Conversely, wall damage in the second and third floor was not observed.

Third floor: Slight periphery wall damage

Second floor: Slight inner-periphery wall damage

Fig.4-6 Earthquake damage to Gopinath Temple

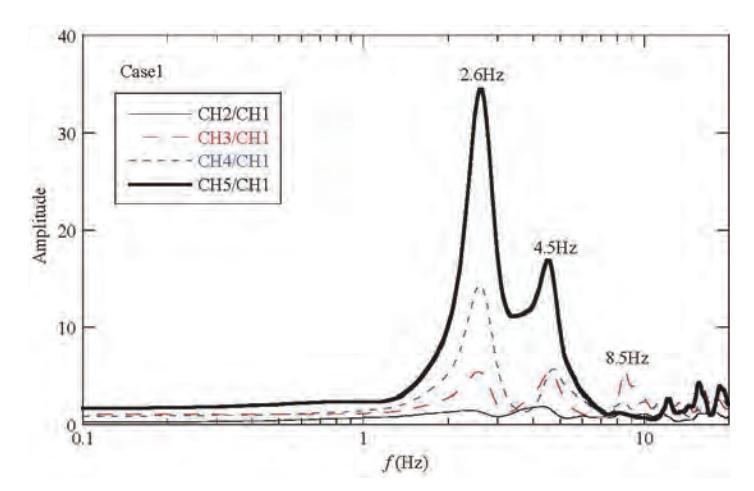
Fig.4-8 Representative Fourier amplitude ratio for the Jagannath Temple (E-W direction)

As a representative measurement result, Fig. 4-8 shows the transfer function in the east-west (E-W) direction for the Jagannath Temple. The transfer function was obtained by dividing the Fourier spectrum of building vibration monitored inside the building by the Fourier spectrum of ground vibration. The peak frequencies of the transfer function—2.6 Hz, 4.5 Hz, and 8.5 Hz—were estimated to be first, second, and third natural frequencies of the building.

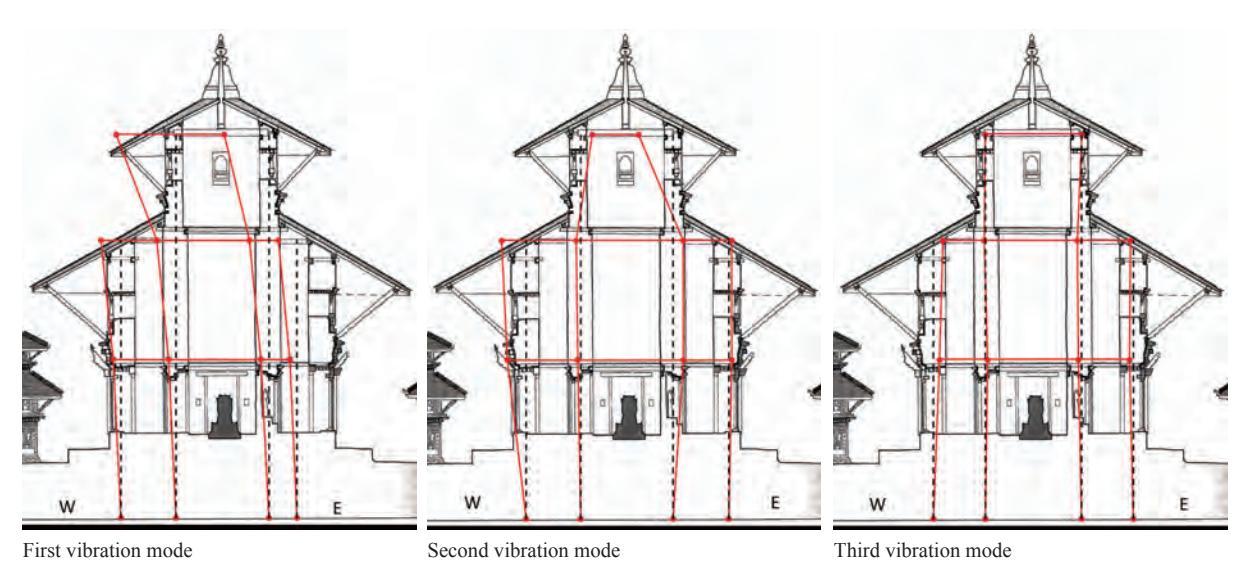
Fig.4-9 Representative vibration mode for the Jagannath Temple (E-W direction)

Fig. 4-9 shows the vibration mode of elevation corresponding to the first, second, and third natural frequencies in the E-W direction for the Jagannath Temple. The vibration mode was obtained from the transfer function and phase information. At the first vibration mode, the third floor amplitude was larger than the first or second floor amplitudes. At the second and third vibration modes, each wall line had different vibration direction suggesting that the rigidity of the horizontal plane was not sufficient.

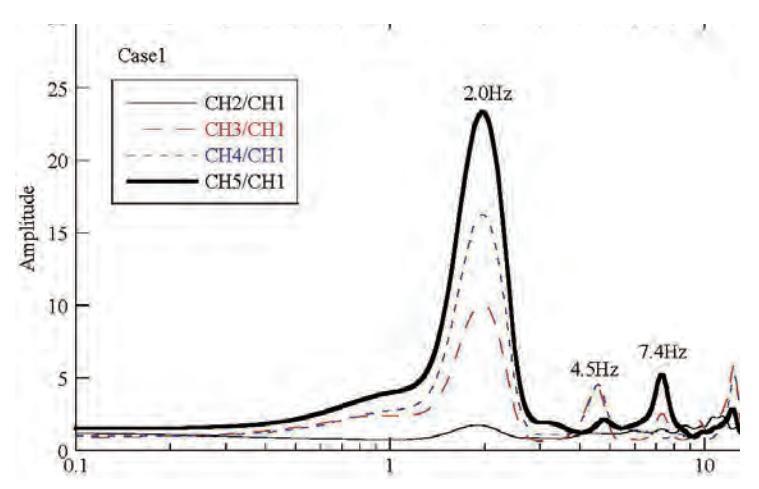
Fig.4-10 Representative Fourier amplitude ratio for the Gopinath temple (E-W direction)

As a second representative measurement result, Fig. 4-10 shows the transfer function in the E-W direction for the Gopinath Temple. Again, the peak frequencies of the transfer function—2.0 Hz, 4.5 Hz, and 7.4 Hz—were estimated to be the first, second, and third natural frequencies of the building.

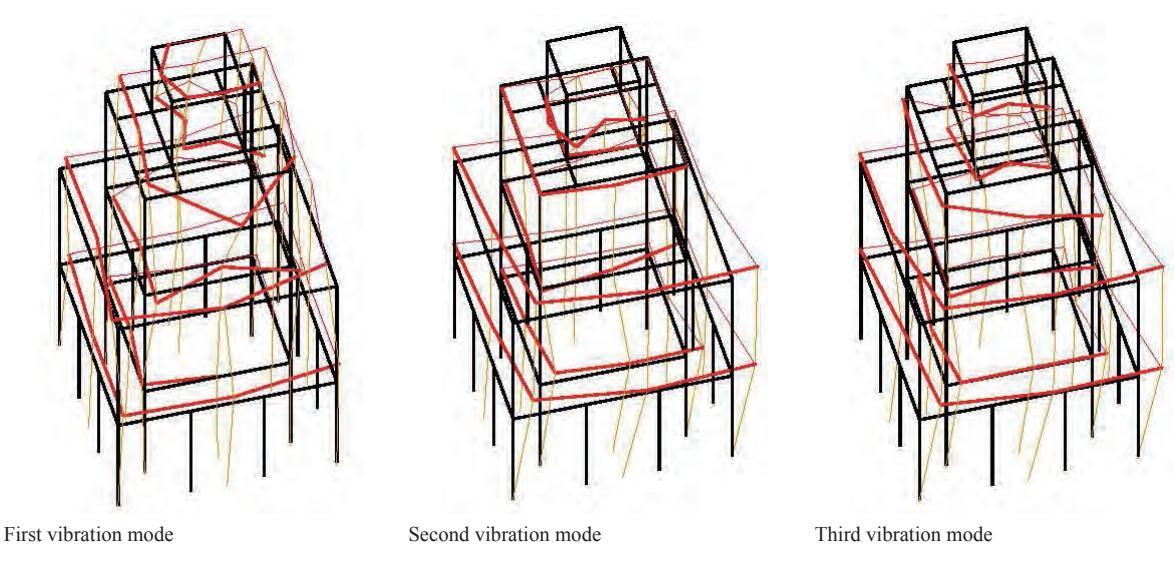
Fig.4-11 Representative vibration mode for the Gopinath Temple (E-W direction)

Fig. 4-11 shows the vibration mode of elevation corresponding to the first, second, and third natural frequencies in the E-W direction for the Gopinath Temple. Fig 4-7 reflects a simplified display that eases difficulty discerning the vibration modes of the inner periphery, periphery, and top floor. The roof shape was also removed to simplify the figure. The amplitude in the out-of-plane direction at the top of the inner periphery walls was large at the first vibration mode. At the second and third vibration modes, amplitudes in the north-south (N-S) direction were large.

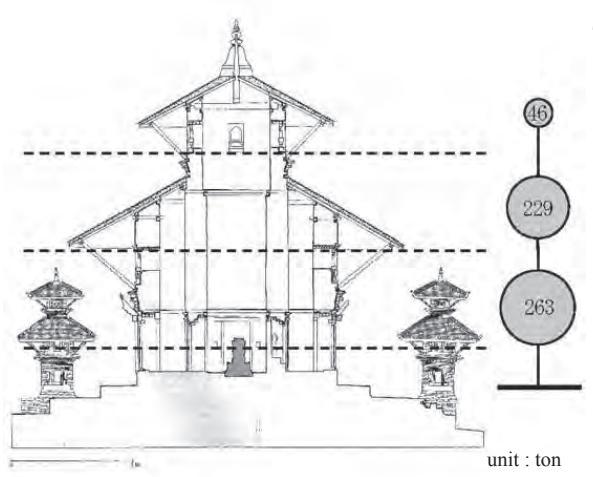
Fig.4-13 Mass point model weights for the Jagannath Temple

Fig. 4-13 shows the weight of each mass point in the Jagannath Temple analysis model. Rooftop pinnacles, small openings, and wall thickness differences were ignored in the weight calculation. Table 4.2 lists the Ai distribution obtained from this weight calculation.

Assuming that the Ai distribution is equal to the acceleration distribution, an input acceleration of 0.25 G (C1 = 0.25) resulted in an output acceleration at the top floor of 0.482 G. Output acceleration may exceed 0.5 G if the external force is larger than the friction resistance between bricks at the top floor. This assumption corresponds with the field survey results for the Jagannath Temple that noted the earthquake damage concentrated at the top floor. A similar tendency is likely observed for buildings with upper floor walls that continue straight to the first floor.

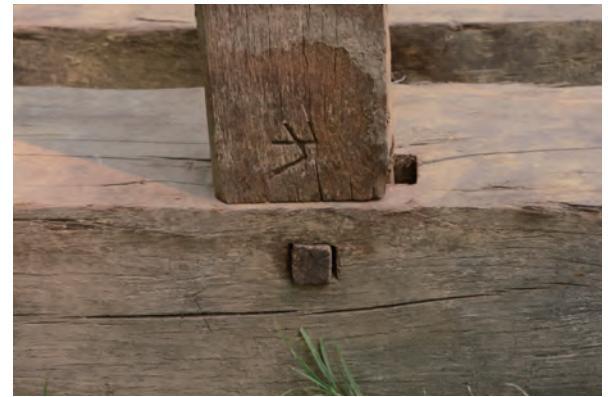
In addition, chisel marks found on some of the members can serve as an indicator for assembly although it was not clear if these marks are original. The chisel marks observed in this survey were scattered and did not always match. However, the chisel marks indicate required member modifications based on their specific position inside a building.

Fig.5-13 Chisel mark

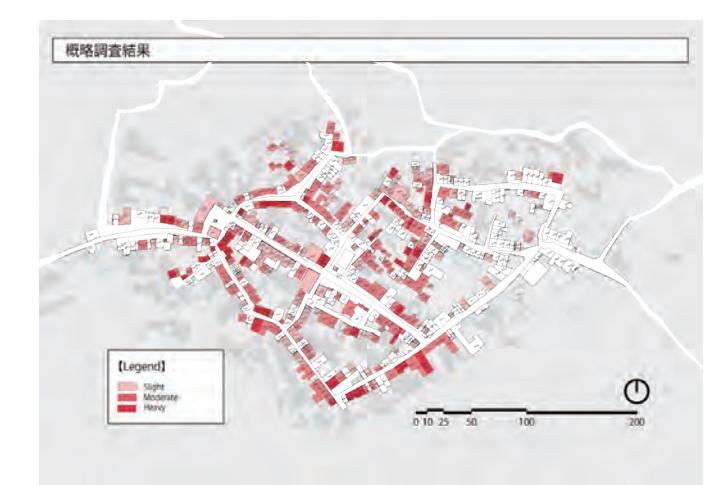
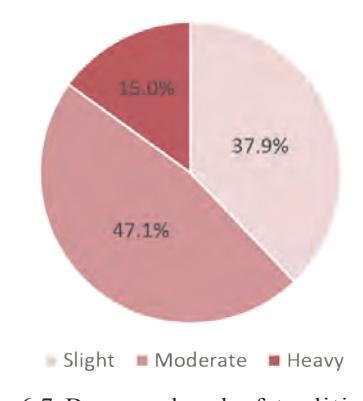
Approximately 15% of the traditionally constructed buildings were completely destroyed; ~47%, partially destroyed; and ~40%, slightly damaged or undamaged (Figs. 6-6, 7). Through hearings, we also found that there were cracks inside the buildings and curving in the floors; this damage needs to be addressed in the future. It is assumed that these results will not match those of the structural judgment, because this is survey strictly concentrates on Damage condition pertaining to the external appearance of buildings.

Fig.6-6 Damage level of traditional buildings in the south area

Fig.6-7 Damage level of traditional Buildings in the south area

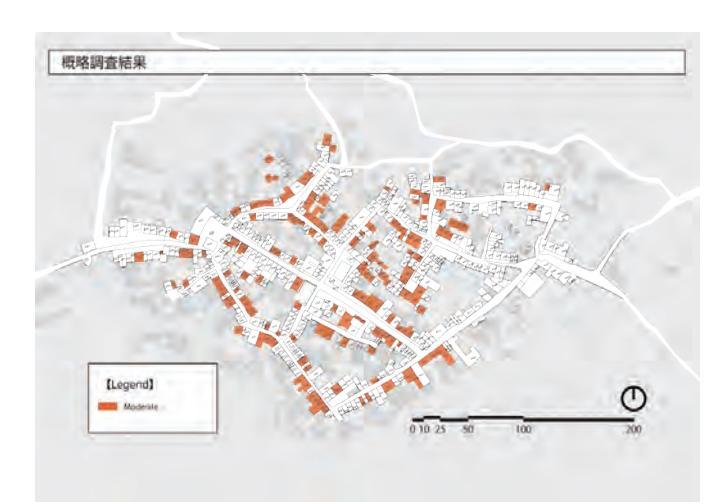
In addition to the issue of the reconstruction method to be used for 52 completely destroyed buildings, the issues of whether existing repair reinforcement construction is possible for 163 traditionally constructed buildings (Fig. 6-8) that have been partially destroyed and the necessity of a concrete presentation of methods also need to be considered. The residents of these partially destroyed buildings dismantled the collapsed ceilings and covered them with zinc-coated steel (Fig. 6-9), and they continued with plumbing work to use their houses as a toilet and storage space during the day and slept at temporary residences at night. To preserve the village house rows, there is an urgent need to establish a repair reinforcement method for partially destroyed traditionally constructed buildings.

Fig.6-8 Location of the traditional buildings that have suffered moderate level damage in the south area

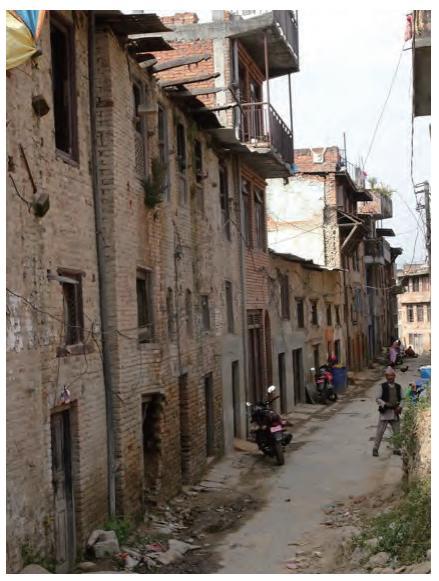
Fig.6-9 Examples of traditional buildings that have suffered moderate level damage

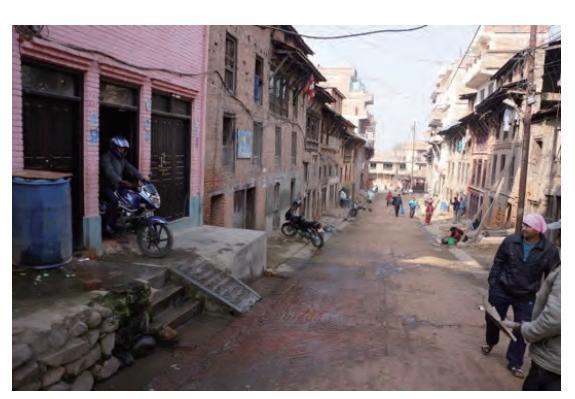
Fig.6-12 Photo of Main street, Nov. 2011

Furthermore, on the main street, we created and analyzed separate cross-sectional figures for traditionally constructed buildings (cross section A) and nontraditionally constructed buildings (cross section B) (Fig. 6-11). The difference in the floor heights and number of floors in traditionally and nontraditionally constructed buildings is clearly changing the landscape of the neighborhood. In many buildings, the floor height of the ground floor was increased, and concrete stairs were constructed to eliminate this gap, thus changing the landscape of the ground level. There was a tendency to use the ground floor as a garage for motorbikes, and in some cases, a slope had been made to the street (Fig. 6-12).

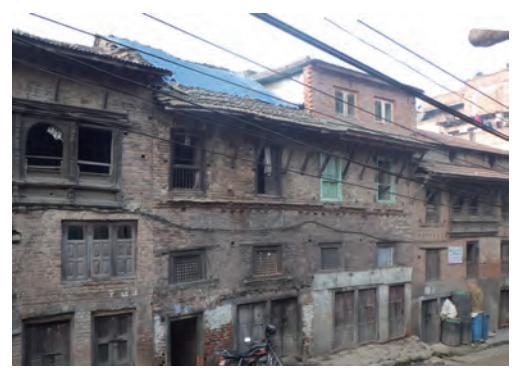
One of the four traditional houses that escaped collapse by the earthquake in 1934 is situated along Nyala Dan street. This house has undergone many transformations, in a manner similar to other houses. However, the piled up stones from before 1934 remain in the foundation, as do engraved members inside, and the original courtyards are kept in good condition. There is also an altar with a deity, and this house is thus a public space for residents. As it is a very important house in the history of Khokana, it is advisable to investigate it in greater detail from the viewpoint of its conservation/restoration.

Fig.6-16 Traditional house constructed before earthquake in 1934 still remain, although the additions have been made

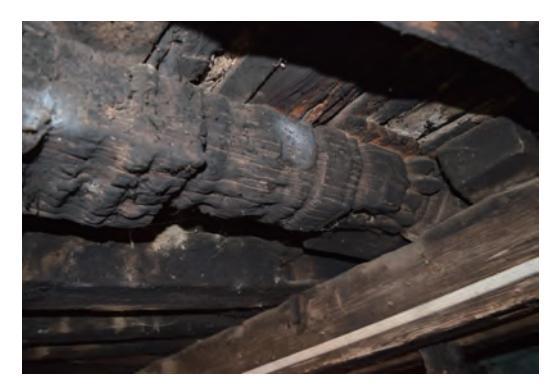
Fig.6-17 Carved pillar that was reused as a beam

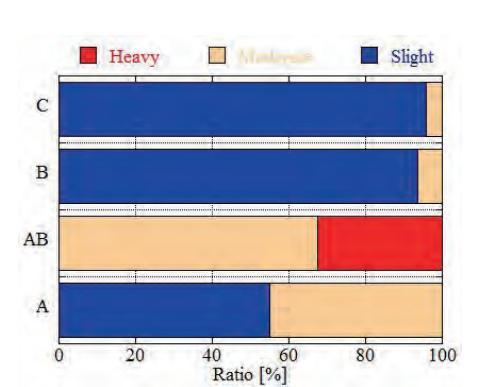
In addition to an exhaustive survey on the damage of buildings in Khokana, a structural analysis of the damage to both traditional buildings and RC buildings was conducted. The definitions of the types of structures and the degree of damage are the same as those used in the study by Tokyo University (Figs. 6-3, 4). Examples of results are shown in Figs. 6-20–6-23. Furthermore, the damage was also analyzed based on the façade drawing before the earthquake and microtremor measurements. The details of this survey are presented in the other volume.

Fig.6-20 Relation between the type of building structure and degree of damage

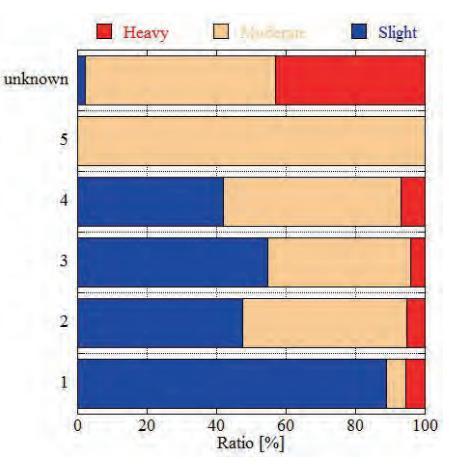
Fig.6-23 Relation between the number of building story and degree of damage
